CITY OF LAMBERTVILLE
HUNTERDON COUNTY

ARCHITECTURAL REPORT SUMMARY CITY OF LAMBERTVILLE

EXECUTIVE SUMMARY

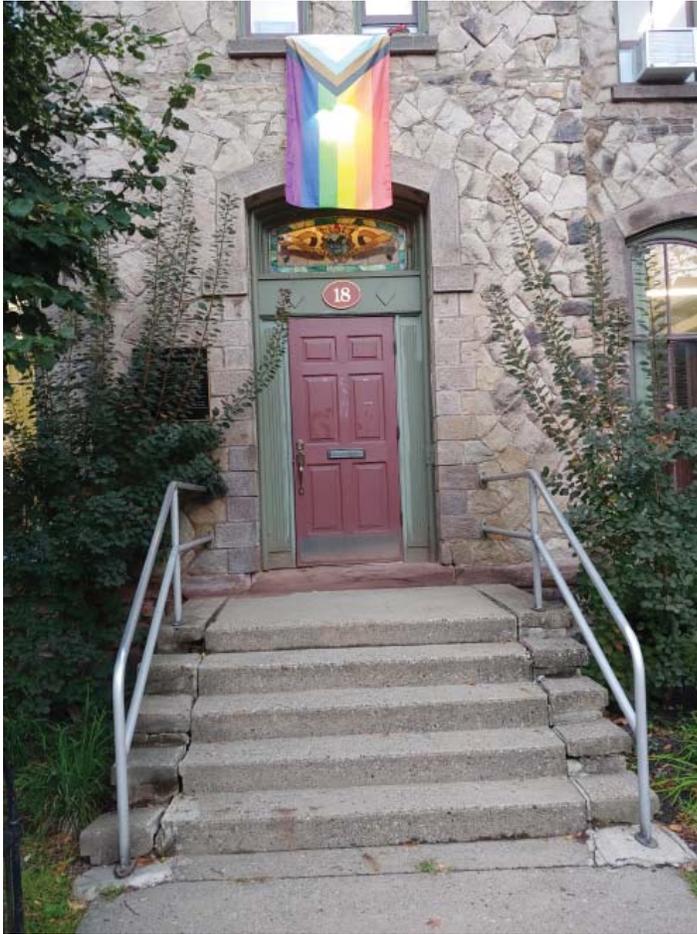
Photo 5
The concrete stairs to the front entrance is deteriorating. The stone support below the stairs is also in need of repair. The stairs and landing are missing 42" high guardrails per IBC 1015.2.

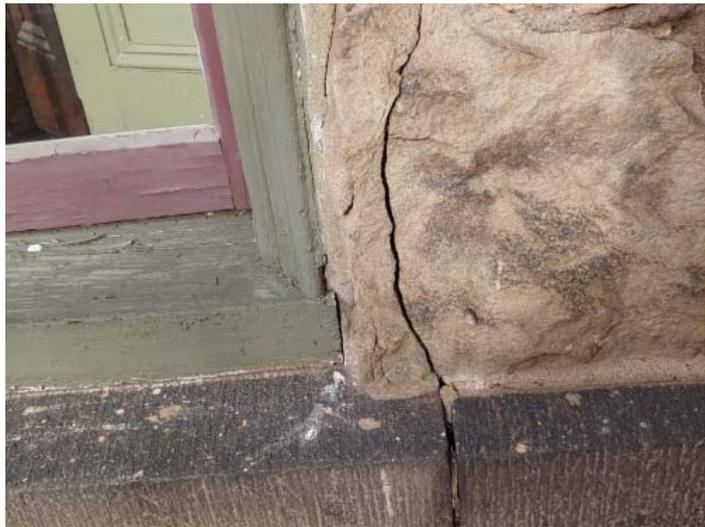
Photo 9
Repoint masonry wall where stone is loose.

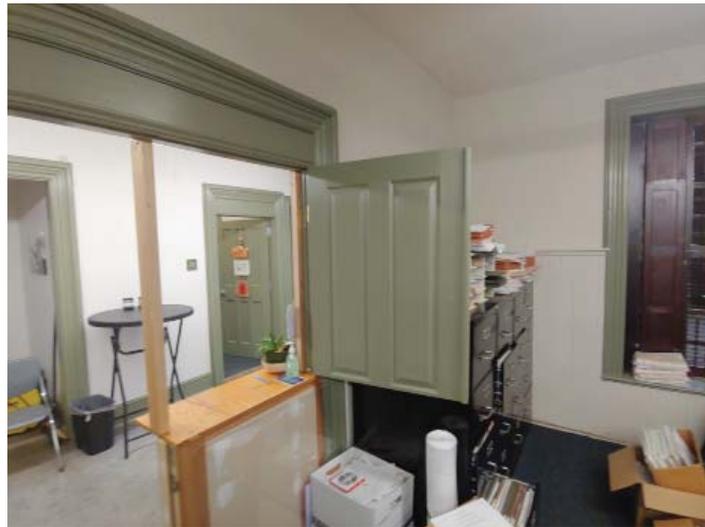
Photo 32
Photo in Office 206. Provide
a wire management system
and install electrical outlets
to handicapped accessible
heights per ICC A1171-2009:
308.21.

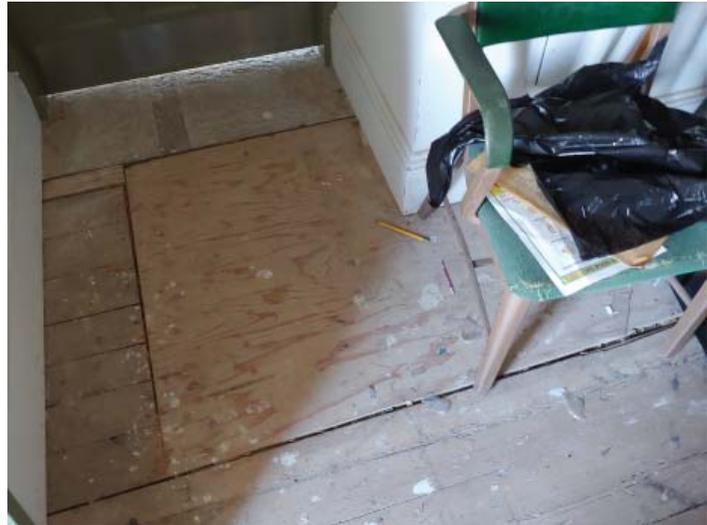
Photo 37
Photo taken in Storage 305. Walls to be repaired. Lighting to be replaced with LED fixtures with control sensors. Water leaks and ceiling to be repaired. Finishes on the ceiling, walls, and floor are missing.

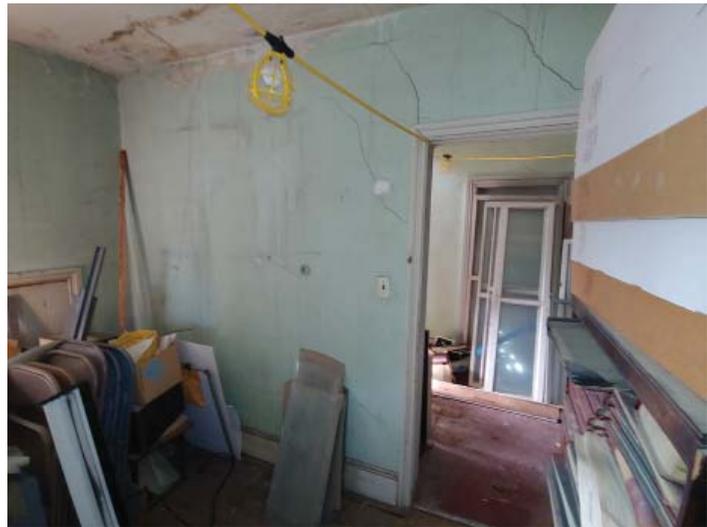
Photo 38
Photo taken in Storage 315. The existing floor structure might not be designed to support heavy loads from shelves with boxes of paper. Refer to structural engineer's report.

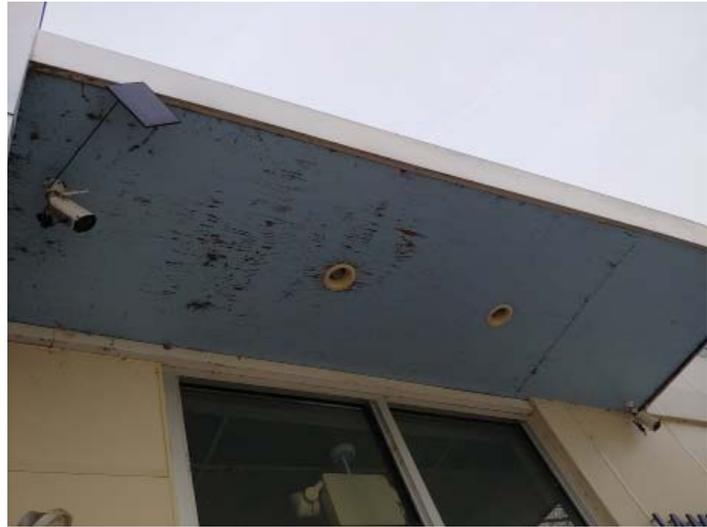
Photo 6
Rod supporting the
front entrance canopy
needs to be painted

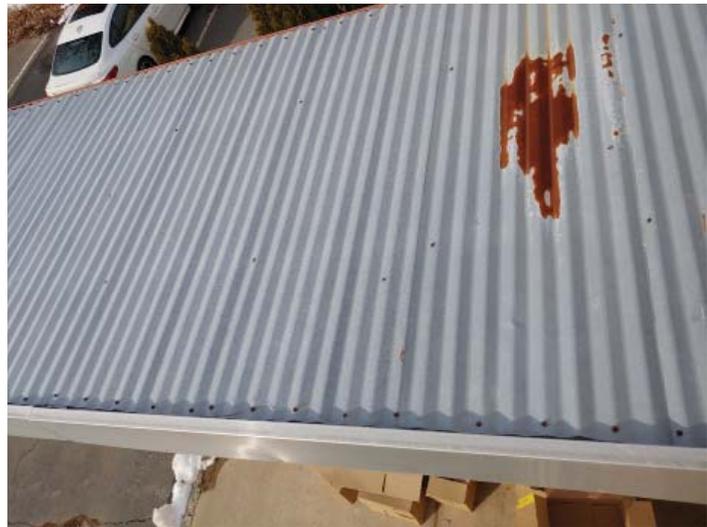
Photo 11
Repair flashing between the
corrugated metal canopy and
EIFS exterior building wall at
back (west) facade

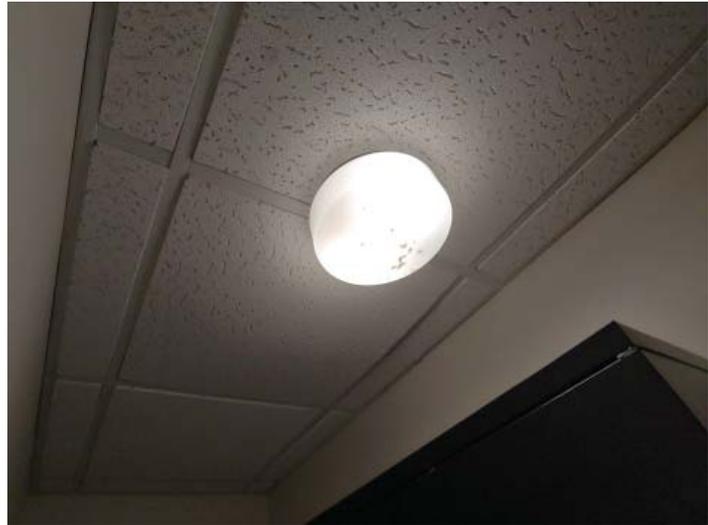
Photo 17
Repair roof leak and water damaged ceiling tile

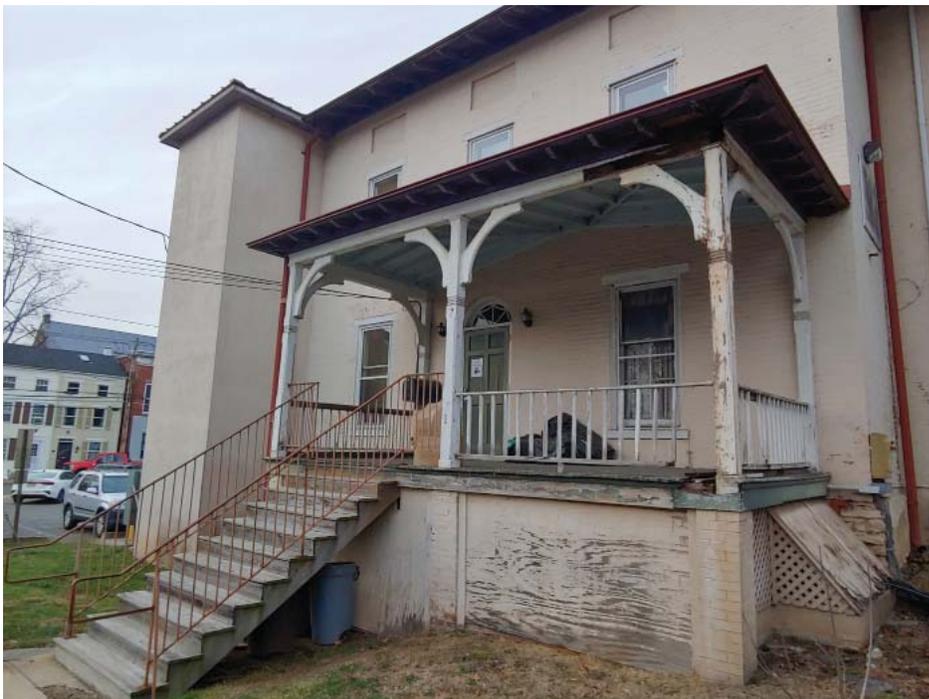
Photo 4
Back (South) facade. All surfaces need to be repainted. The plywood hatch cover at the right side of the porch needs to be replaced. Some of the porch floor planks and guardrail need to be replaced. Repaint the stair handrails. Repoint stone foundation wall, parge and repaint. Repoint masonry wall and repaint.

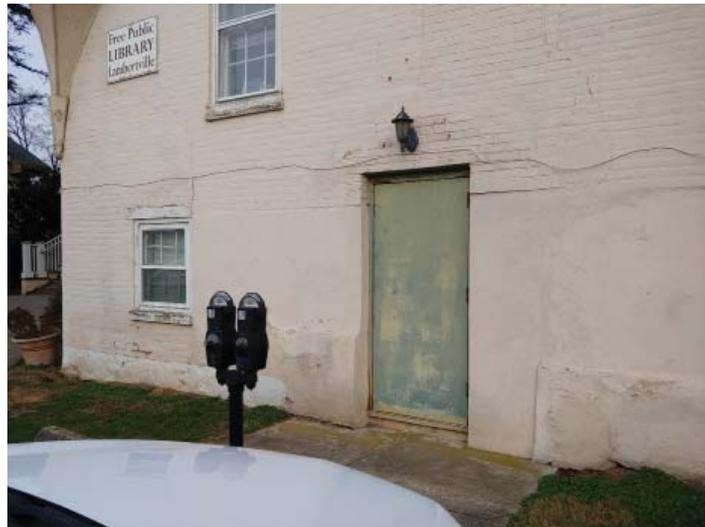
Photo 6

Repoint and repaint brick. Re-parge over foundation and paint. Replace windows with insulated windows. Repaint window sill and trim.

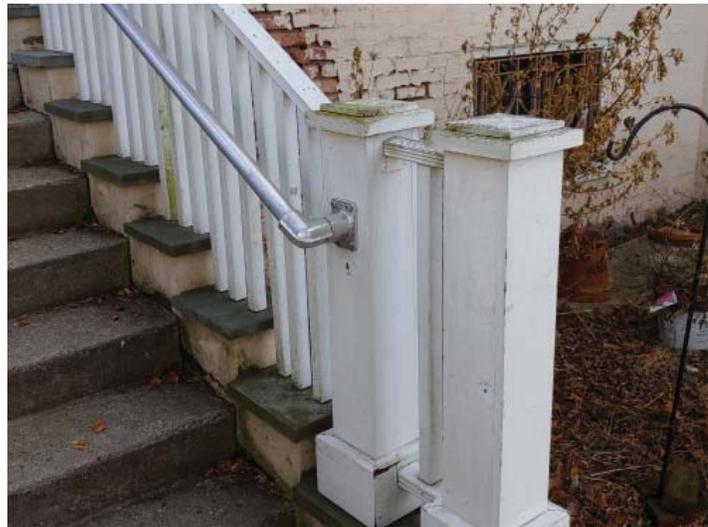
Photo 12
The stringer is separating from the concrete stairs to the front entrance. Stairs to be rebuilt.

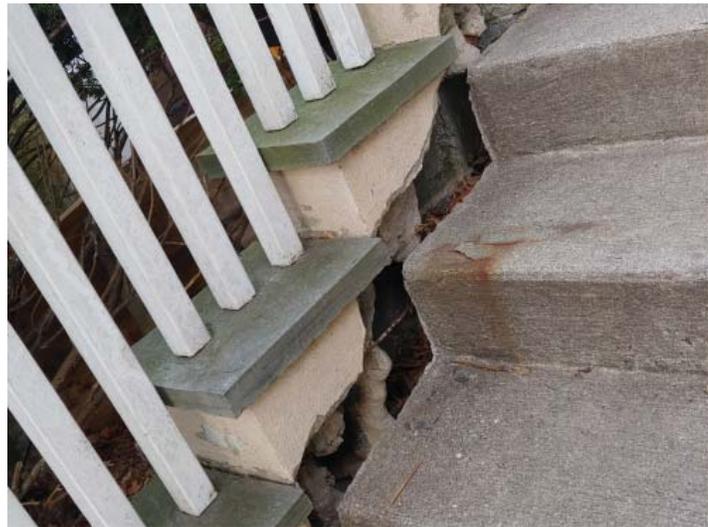
Photo 13
Repair or replace guardrail and posts. Remove the organic growth. Repair the cracking concrete landing.

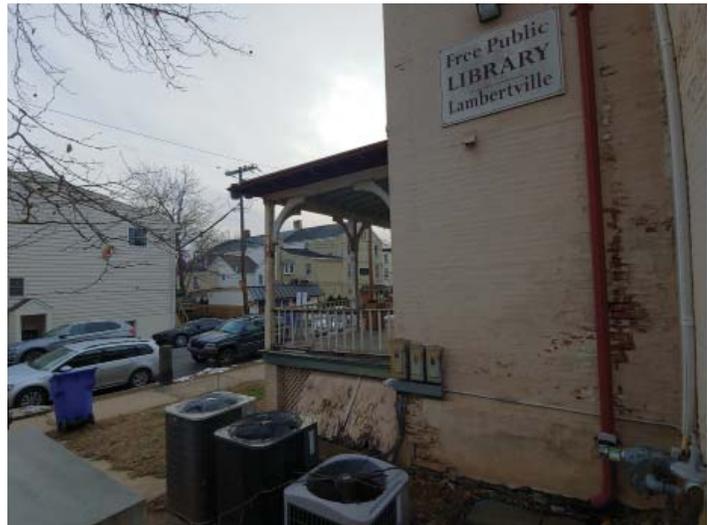
Photo 24

Photo along the wall between the wall with the porch and handicapped ramp. Repoint and repaint brick.

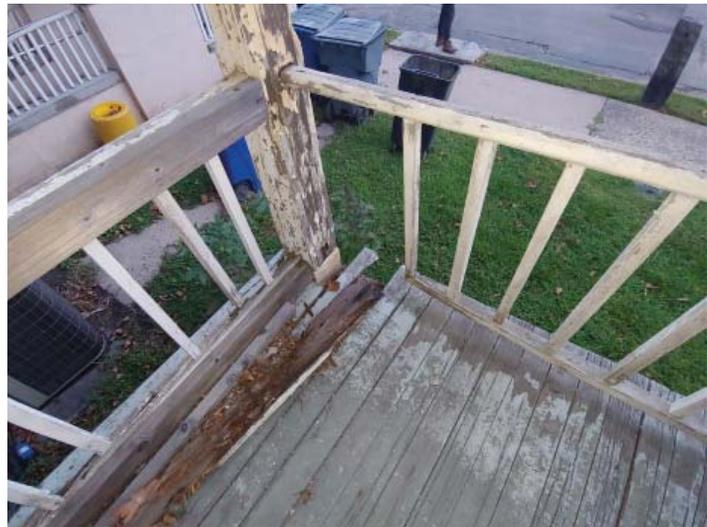
Photo 29
Photo of the back porch. Seal
the exposed unfinished wood
stair risers and treads to extend
the expected use of the existing
stairs. Repaint the stair handrails.
Repaint plywood under the porch.
Repair and repaint guardrail. If
the guardrail is to be replaced, it
will need to have balusters closer
than the existing balusters so a
4 inch diameter sphere cannot
pass between them. Replace the
deteriorated sidewalk up to the
stairs and down to the basement.

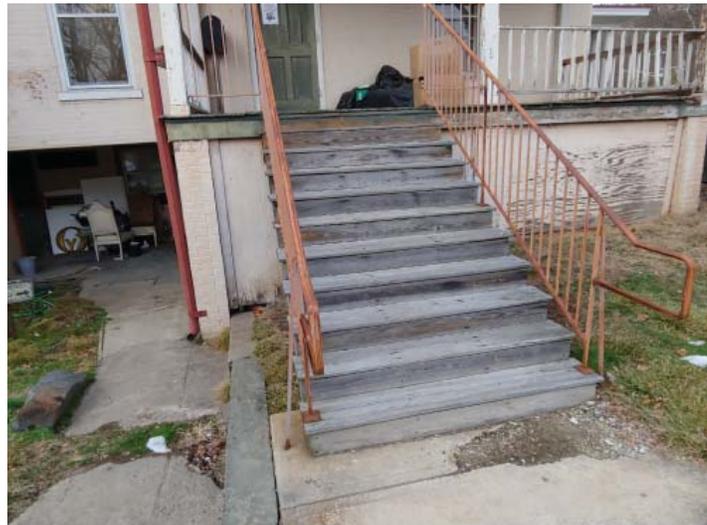
Photo 30
Repair and repaint the wood
planks at the back porch. Seal
or paint the wood stairs treads
and riser. Repaint handrails
and guardrails. This photo also
captures the large gaps in the
sidewalk that is not handicapped
accessible beyond. The sidewalk
needs to be replace along the
south side of the building.

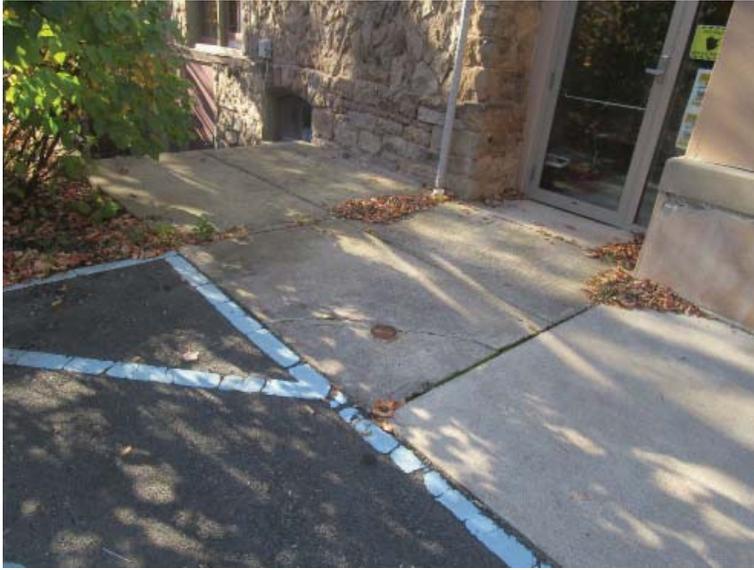
CRACKED SIDEWALK NEAR ADA ENTRANCE

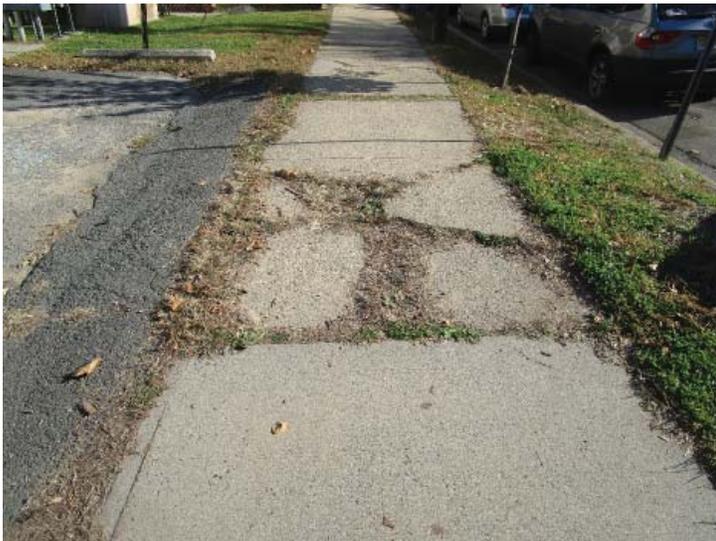
DAMAGED SIDEWALK ALONG LILLY STREET

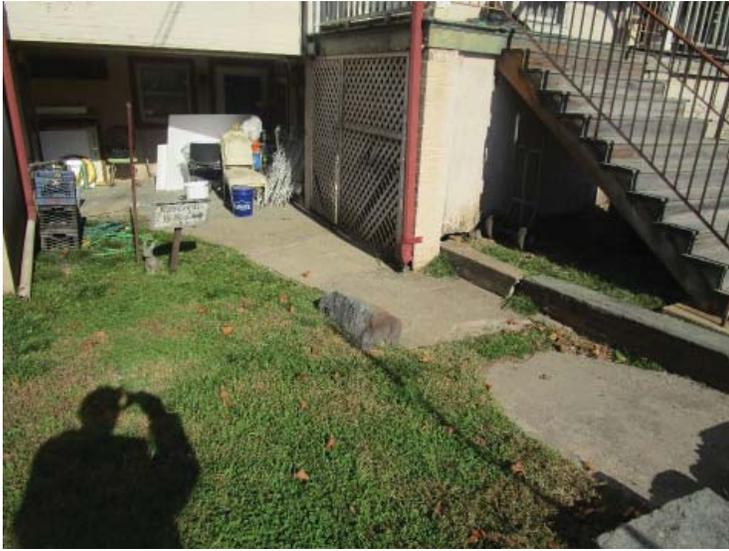
DAMAGED STONEWORK NEAR STEPS

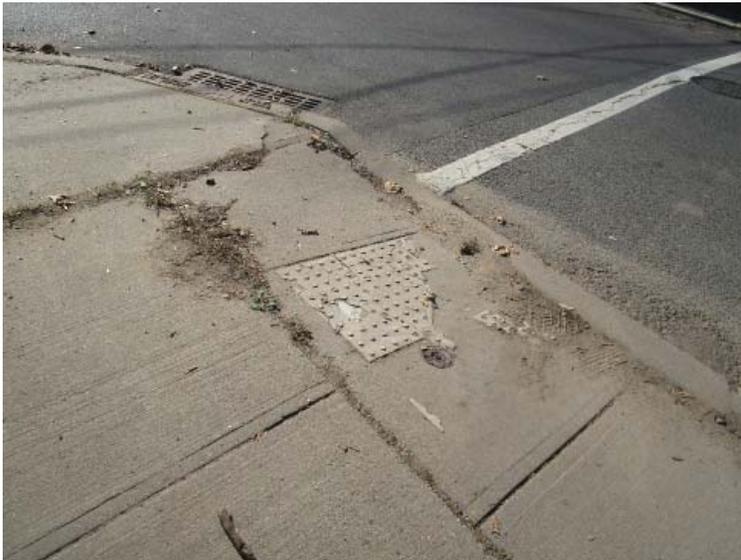
DAMAGED DETECTABLE PADS

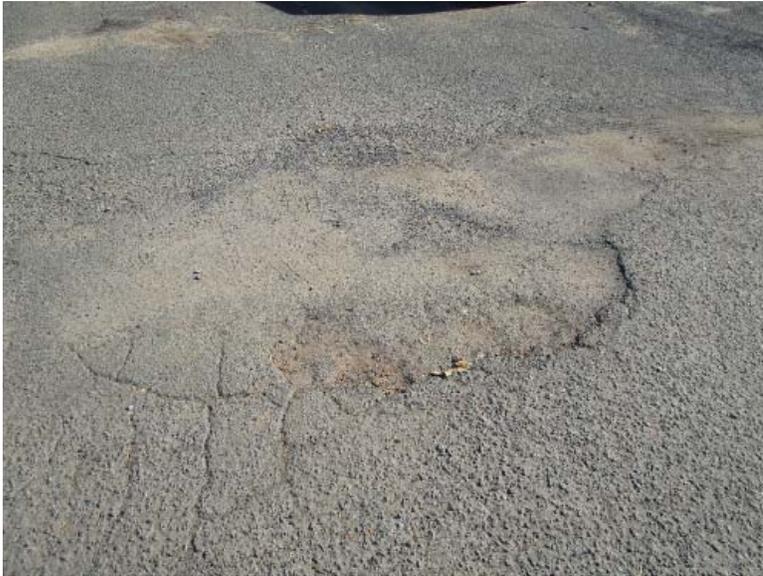
PAVEMENT IN POOR CONDITION

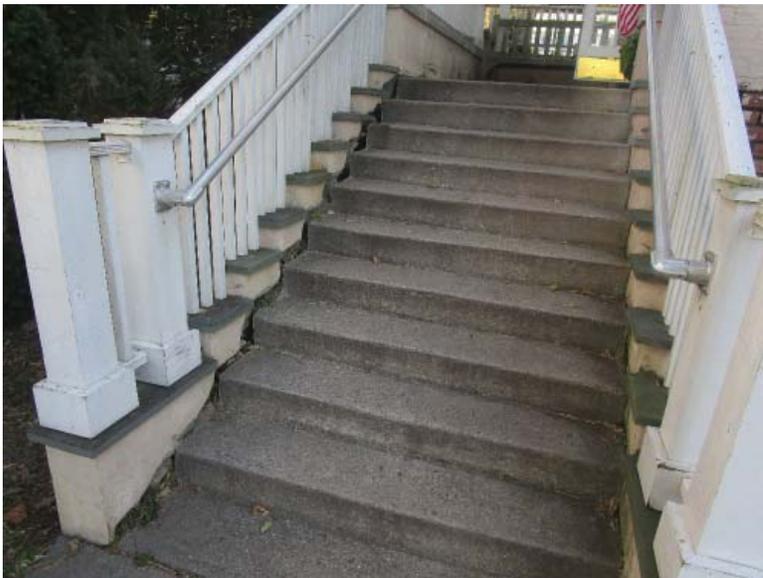
STAIRS SEPARATING FROM WALL

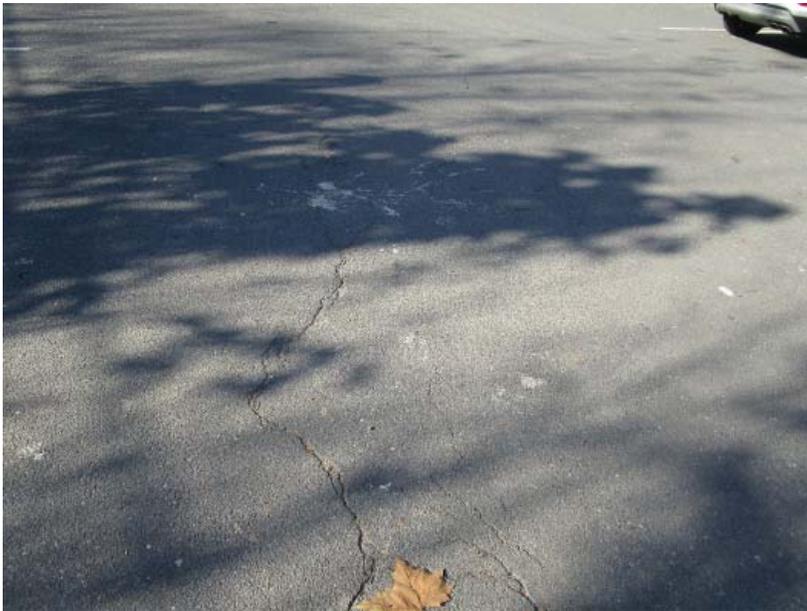
SPIDER CRACKS IN PARKING LOT

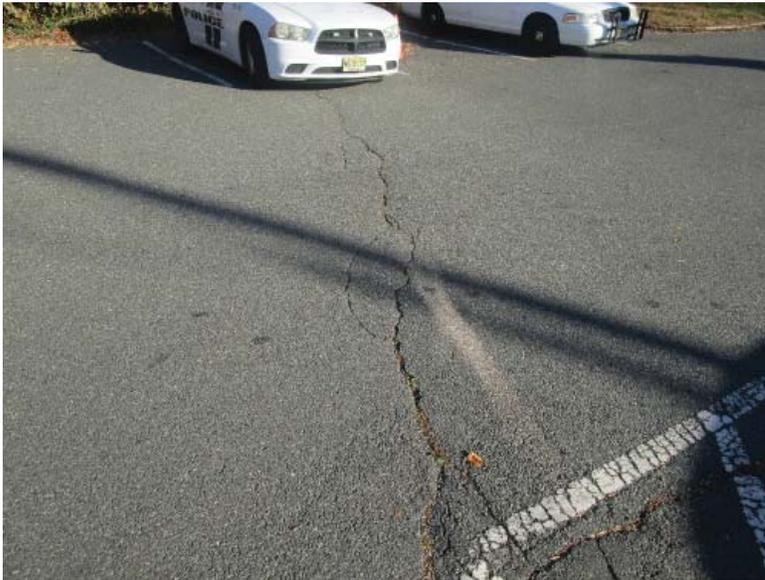
SPIDER CRACKS IN PAVEMENT

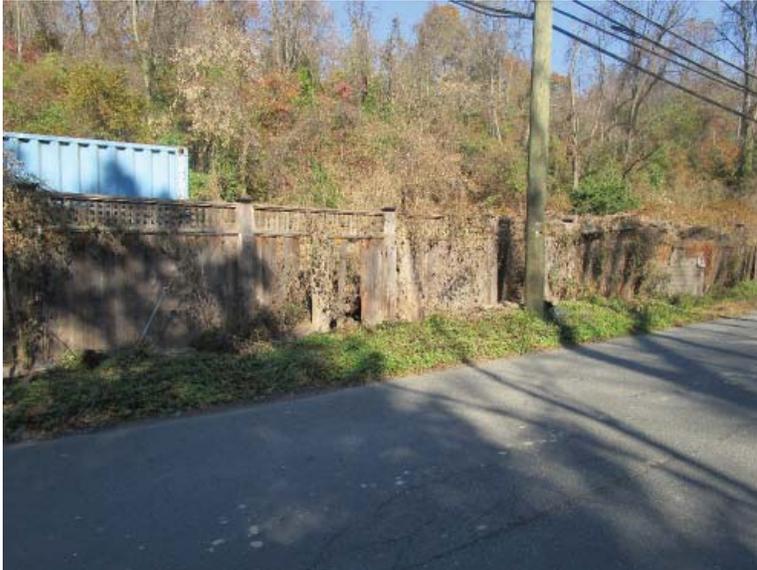
DAMAGED FENCE ALONG QUARRY STREET

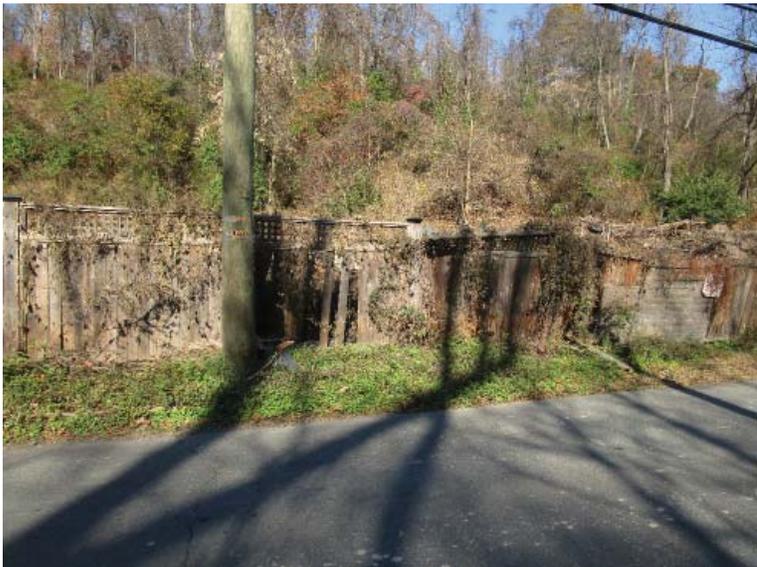
DAMAGED FENCE ALONG QUARRY STREET
