Young Men's Athletic Club

Investigation of an Area in Need of Rehabilitation

APRIL 12, 2019

City of Lambertville, Hunterdon County, New Jersey

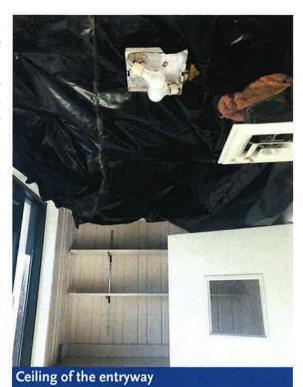
During the visit this office witnessed:

- missing flooring in the main room, the kitchen, and the basement;
- evidence of water damage exhibited as staining on the ceiling tiles; and
- missing/boarded up windows in the basement.

Mr. Anthes informed me that the water was shut off after a pipe froze causing water to pour into the entryway. Subsequently the members of the YMAC covered the entryway ceiling with black plastic in an effort to maintain heat.

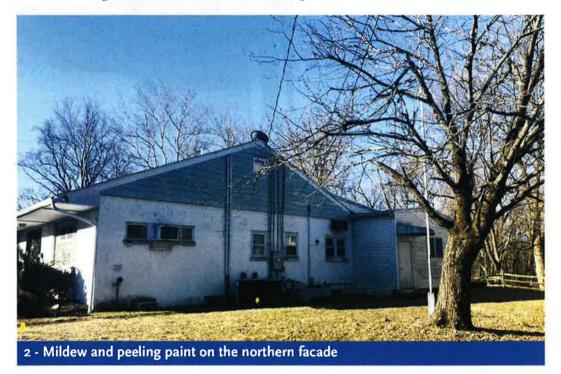
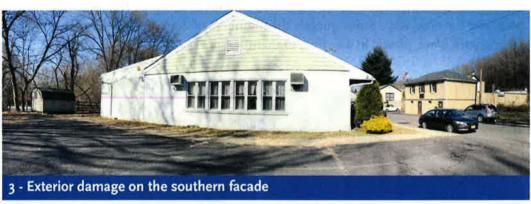
This office also witnessed the following exterior conditions related to the YMAC building:

- Mildew on the siding on the northern facade;
- Peeling and cracking paint on the northern, eastern, and southern facades;
- Missing siding on the southern facade;
- Missing portions of a downspout on the southern facade; and
- Damaged attic vent on the southern façade.

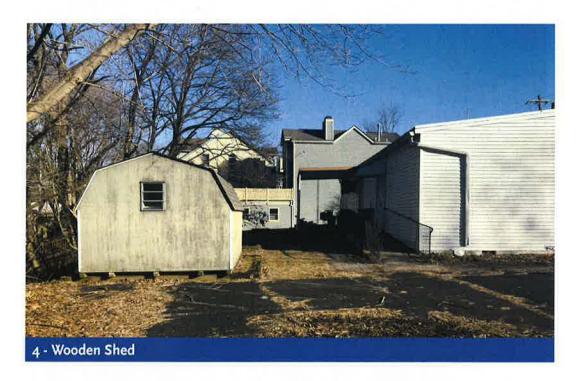
Wooden Shed

A prefabricated wood frame/T-III sided shed is located between the YMAC building and the rear property line. The Lambertville Zoning ordinance, §404.3, does not identify sheds as a permitted accessory use for a club use. Within the R-2 district, sheds are permitted when associated with a residential use only. It appears to be in fair condition, but without permanent footings.

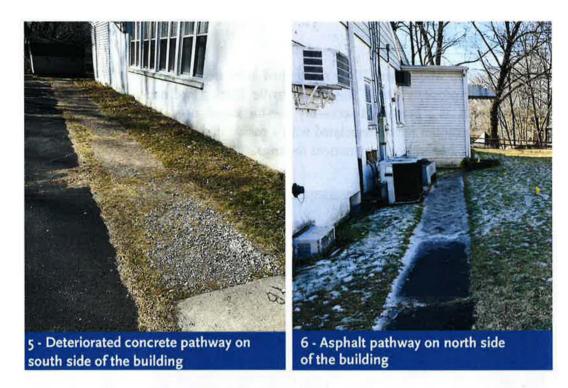
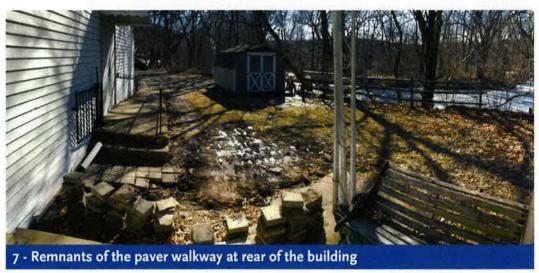
Pedestrian Walks

The site contains a series of pedestrian walks, composed of concrete, asphalt and pavers, that are in various conditions. These walks provide connections between the street sidewalks, around the building and to an asphalt parking area. Along the southern façade of the building, the concrete has deteriorated into gravel in some locations. The pedestrian walk along the northern façade has some cracks with herbaceous vegetation sprouting through. Remnants of a paver walk in the back of the

building remain; however, a majority of it was removed when an underground storage tank was removed in January 2019. The paver walkway was not reconstructed leaving the site in a disturbed and unsafe condition. The overall condition of the pedestrian walks is deteriorating.

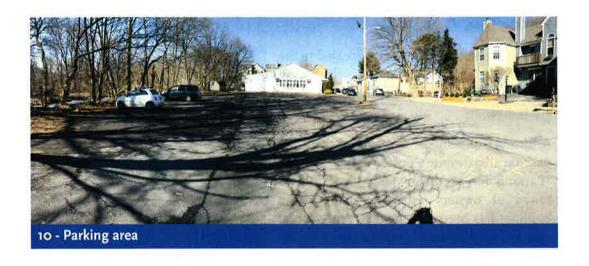
As evidenced in the photo herein, the parking area is an extension of the Wilson Street right-of-way. In fact, a row of parking spaces are accessed directly from Wilson Street.

The parking area is surfaced with asphalt pavement that is showing signs of deterioration through visible cracks and potholes.

The driveway and parking area lacks curbing along its entire perimeter. Additionally, a full length depressed curb was not installed along the gutterline of the driveway at its intersection with Wilson Street.

The parking area is not screened at all since eight spaces are accessed directly from Wilson Street.
