CITY OF LAMBERTVILLE
HUNTERDON COUNTY

ARCHITECTURAL REPORT SUMMARY CITY OF LAMBERTVILLE

EXECUTIVE SUMMARY

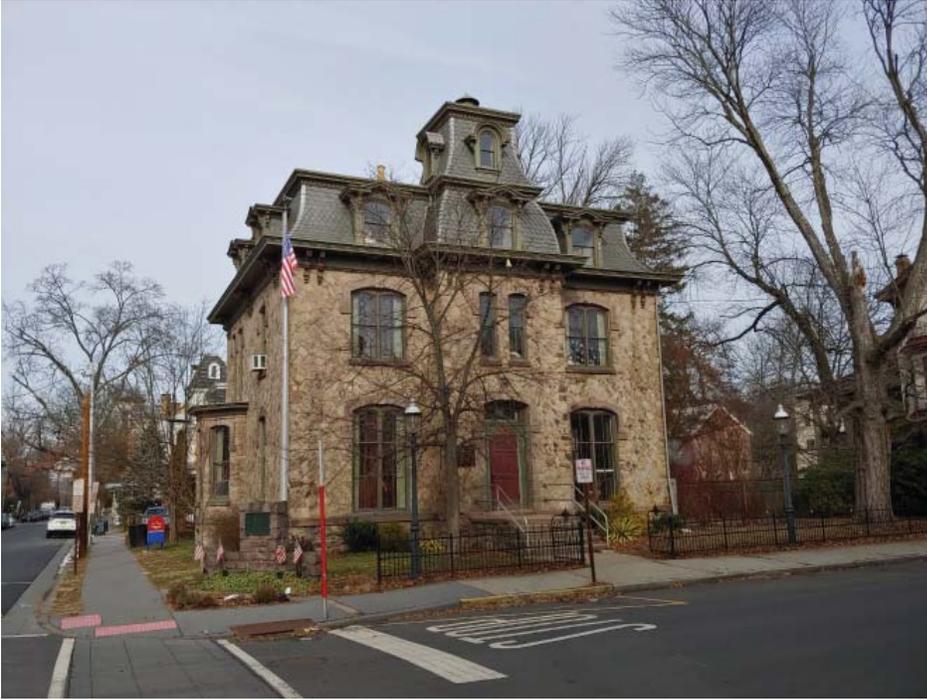
Photo 1
Front facade along
York Street

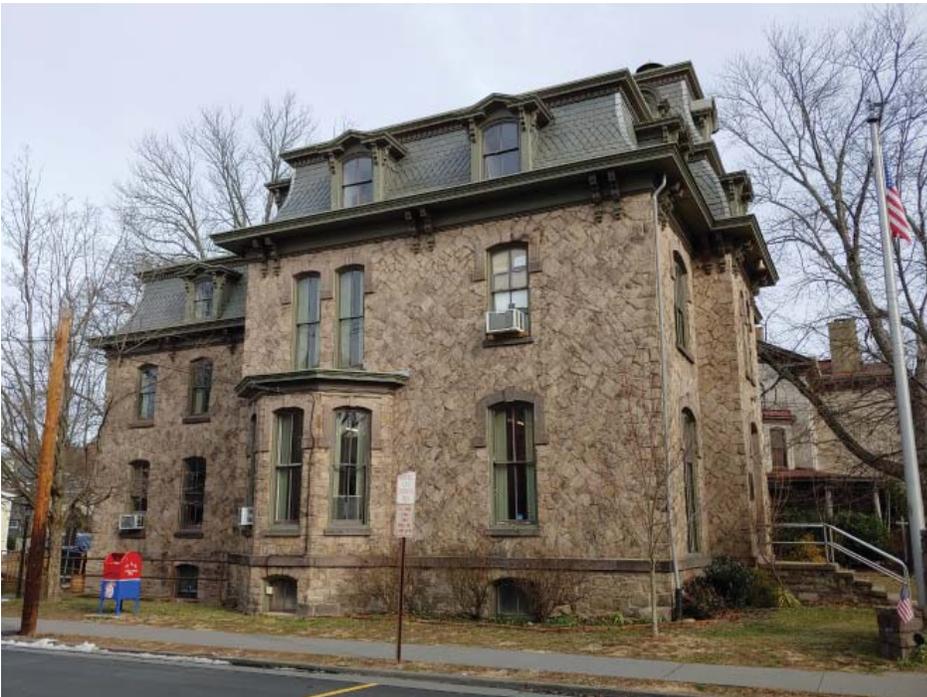
Photo 2
West facade along N.
Union Street

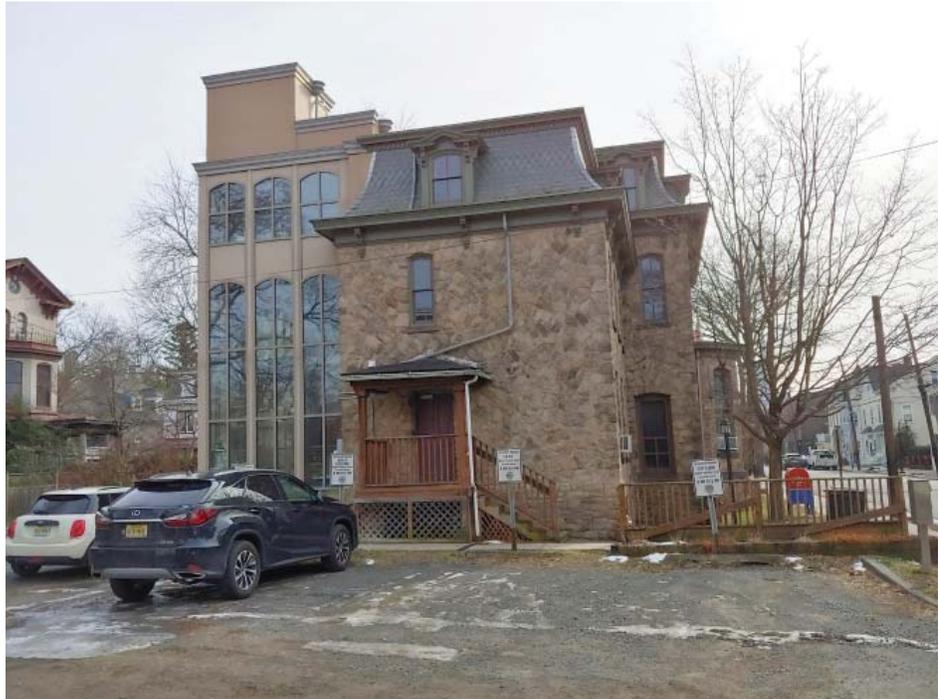
Photo 4
East facade

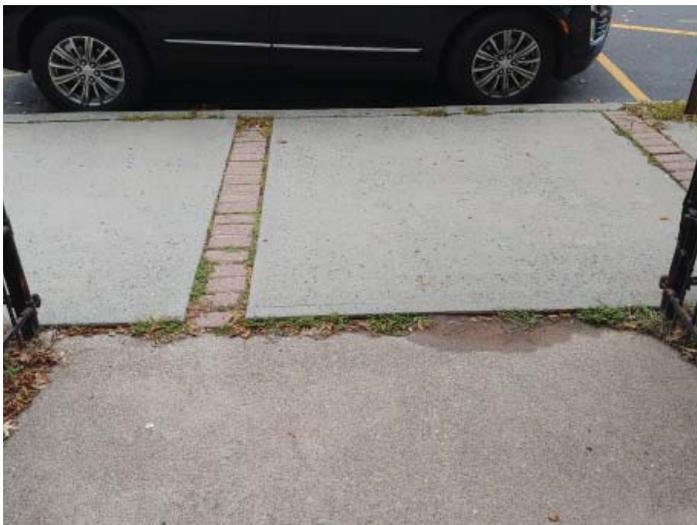
Photo 6
Front sidewalk is uneven and can be a tripping hazard

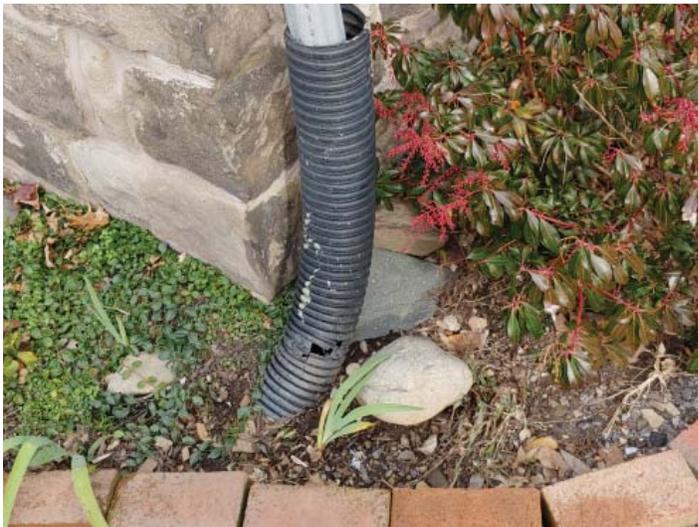
Photo 10
The boot connected to the rain leader has been damaged and needs to be replaced.

Many of the downspouts from the roof gutters are not aligned with the downspout boot at the ground level. They need to be repaired and realigned. Some of these existing boots are filled with soil and will need to be cleaned out before connecting them to the downspouts. Other downspouts need a splash block where they spill onto the ground to avoid erosion near the foundation.

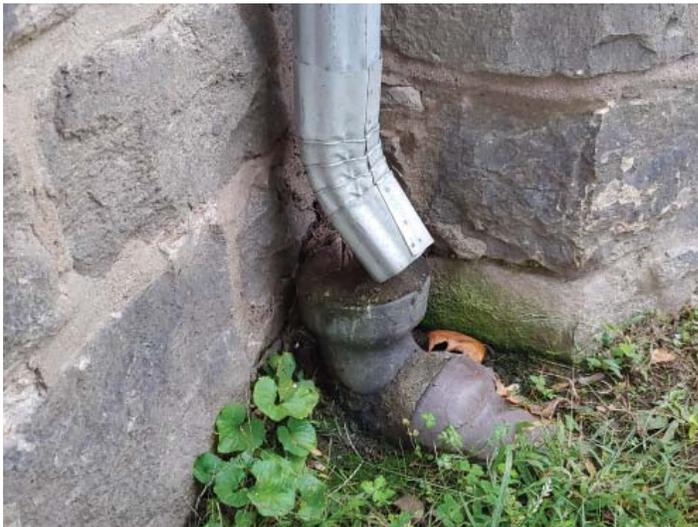
Photo 11
The drain line needs to be cleaned and the leader connected with a boot

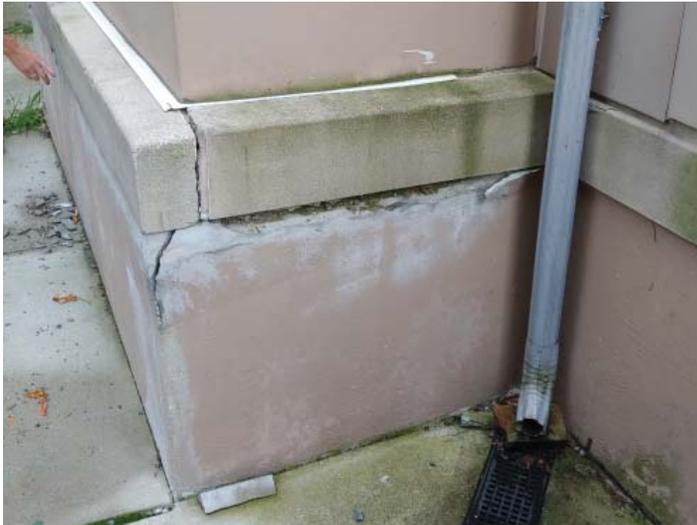
Photo 15
Damaged wall outside of the elevator shaft. The joints in the sidewalk is also expanding allowing vegetation to grow within the joints. There is mold growing on the base of the wall and on the precast concrete

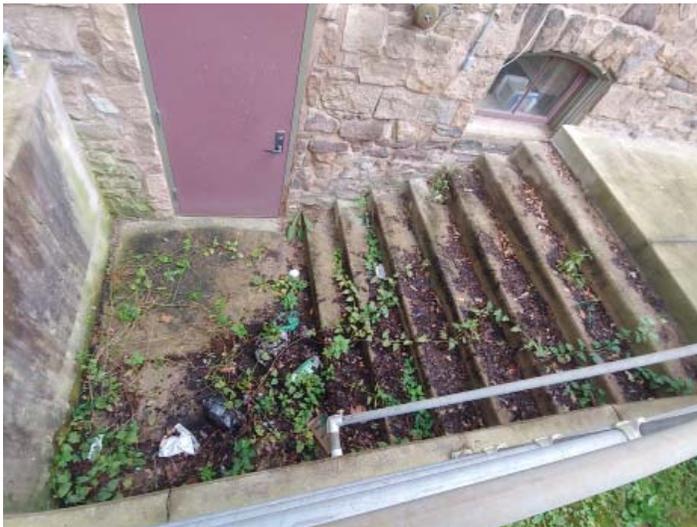
Photo 16
Vegetation growing in an exterior stair, along the east facade, needs to be cleared away. The drainage at the bottom landing of the stairs needs to be cleaned and repaired.

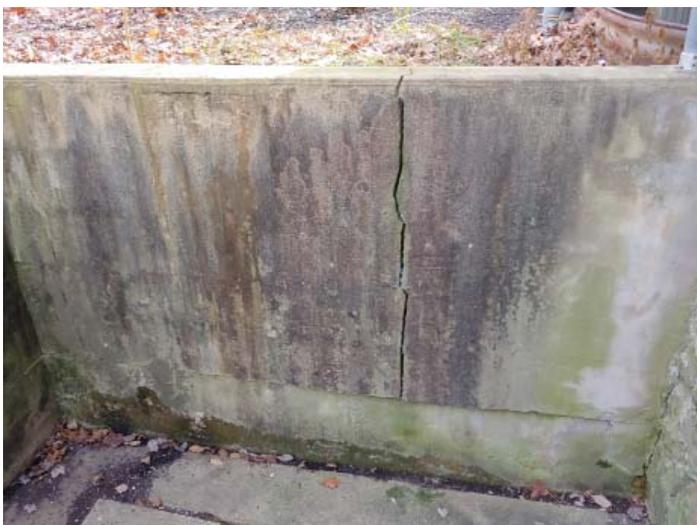
Photo 17
Repair concrete retaining wall near exterior stairs along the east facade.

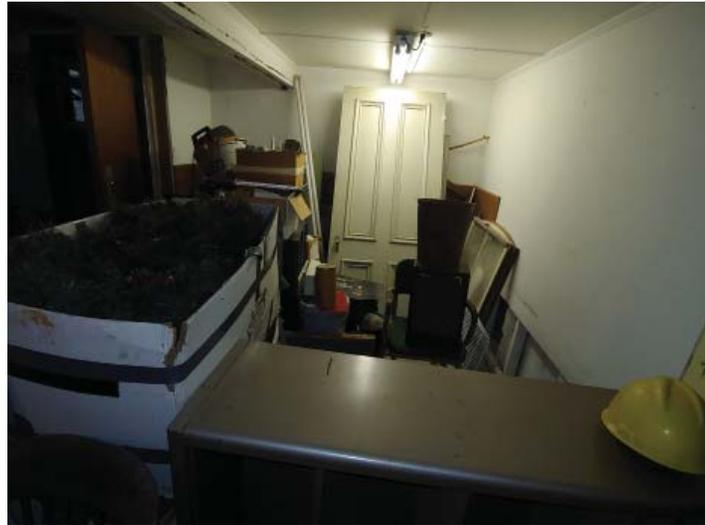
Photo 18

Photo in basement showing a beam with cracked drywall to be repaired, gypsum board missing along the bottom part of the stud wall, and surface mounted fluorescent light fixture that should be replaced with an LED light fixtures (typical throughout the building). More order of how the items are stored would benefit in having a more efficiently used space for storage.

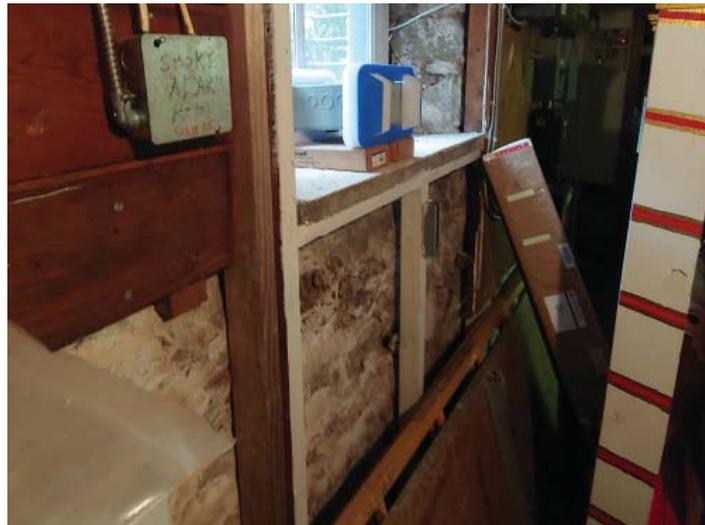
Photo 19

Basement showing the stone foundation wall without insulation.

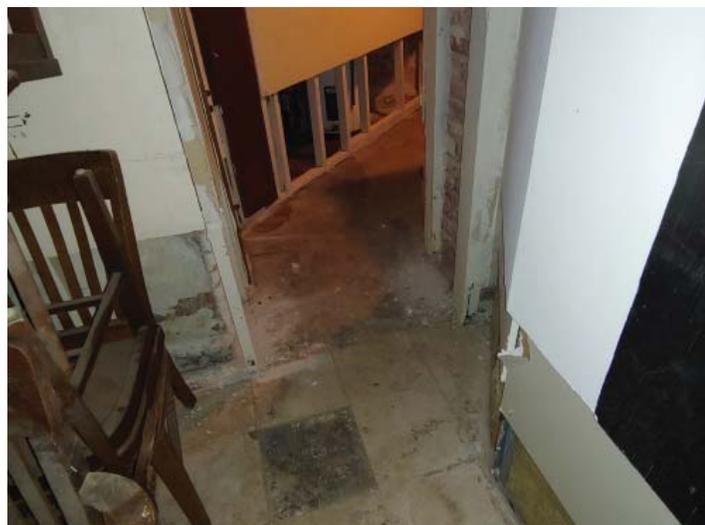
Photo 20

Basement showing how the floor and wall finishes need to be replaced.

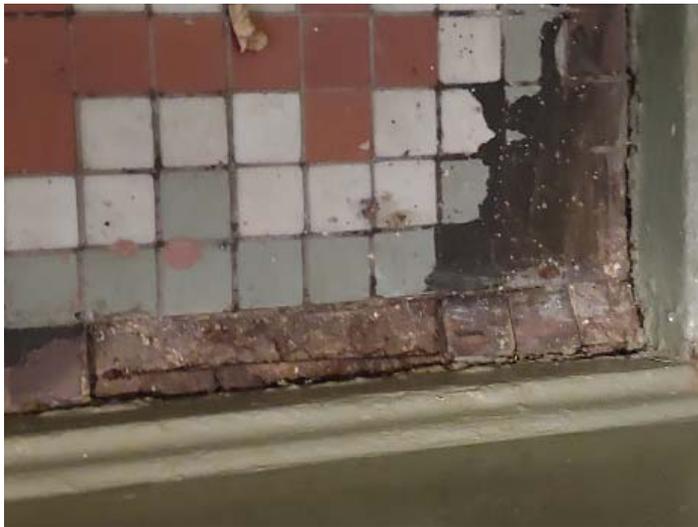
Photo 21
The first floor vestibule needs restoration to the ceramic tile floor.

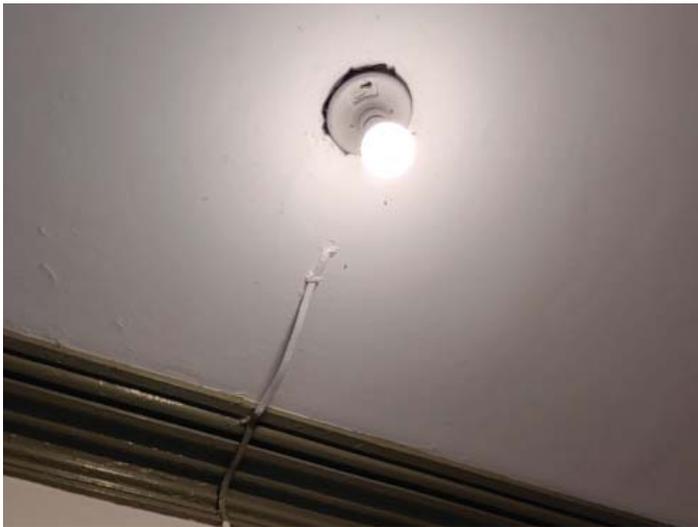
Photo 22
The light fixture in the first floor vestibule should be replaced with an LED light fixture that is controlled by a sensor. Aesthetically, the wires should be concealed and there should not be a large gap at the ceiling around the light fixture.

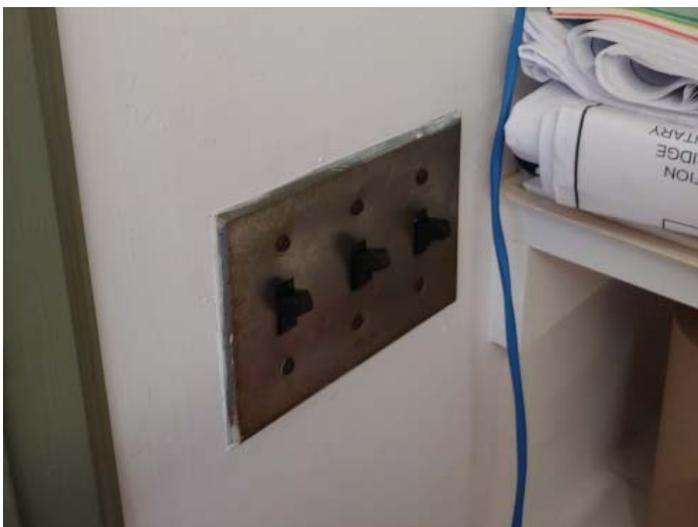
Photo 23
While the lights in the first floor conference room are LED fixtures, the light controls should be replaced with sensors.

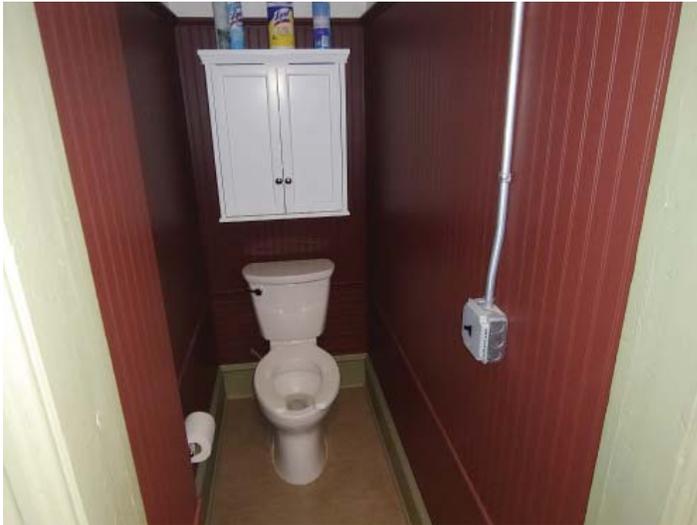
Photo 27
Water closet under the stairs at the first floor is not handicapped accessible per IBC NJ 1109.

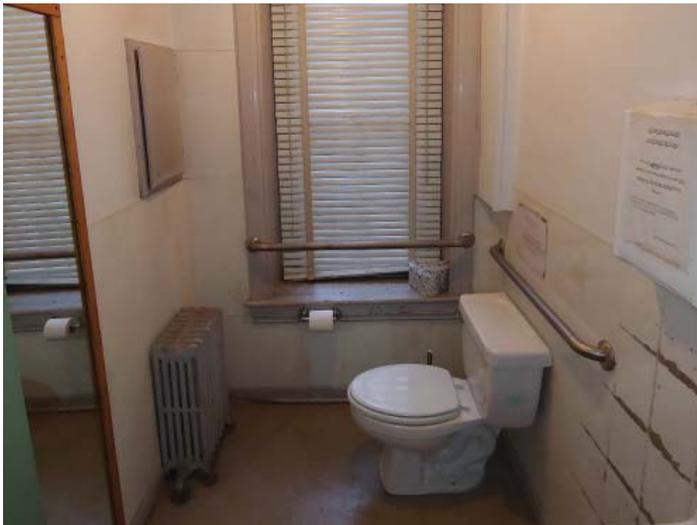
Photo 28
Water closet at the first floor is not handicapped compliant with the vertical grab bar missing at the side wall and radiator within the 56" dimension required to the back wall of the water closet per IBC NJ 1109 and ICC A1171-2009: 604.3.2 and 604.5.

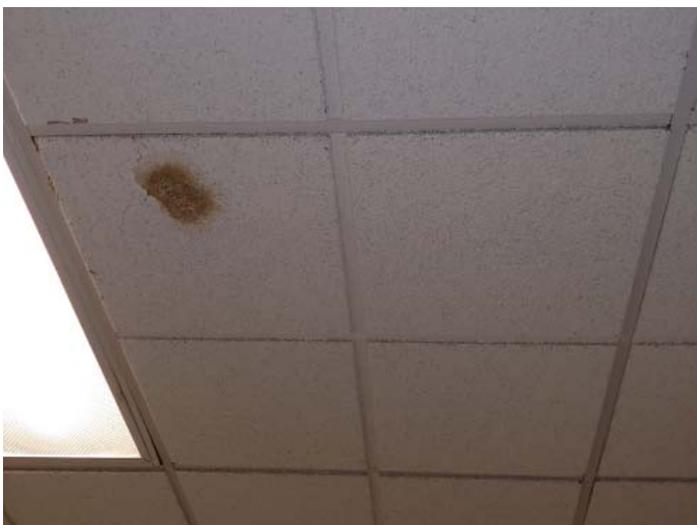
Photo 29
Repair water leak and ceiling tile in the clerk's office on the first floor.

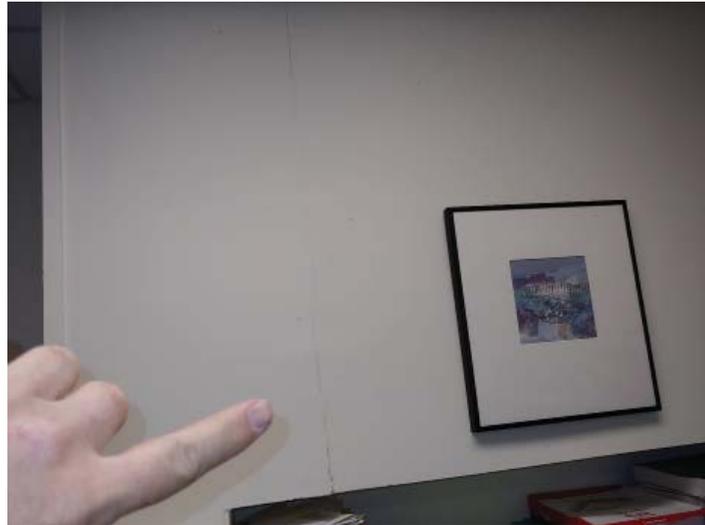
Photo 31
Repair and finish wall
between the Stair Landing
205 and Office 206.

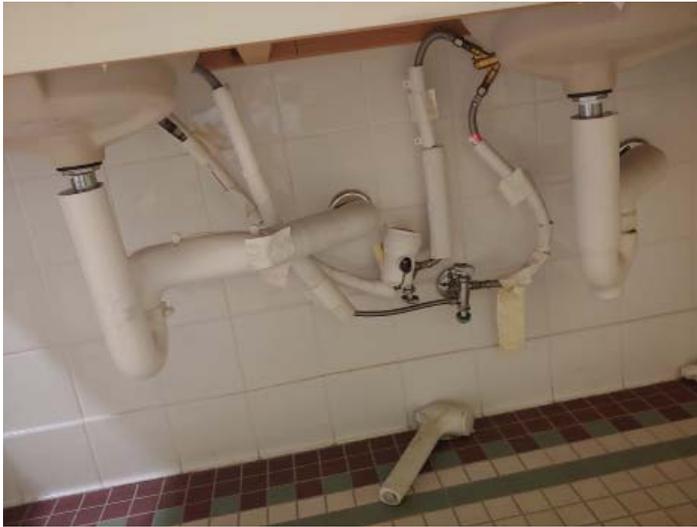
Photo 33
Reinstall pipe
insulation in Toilet 210.

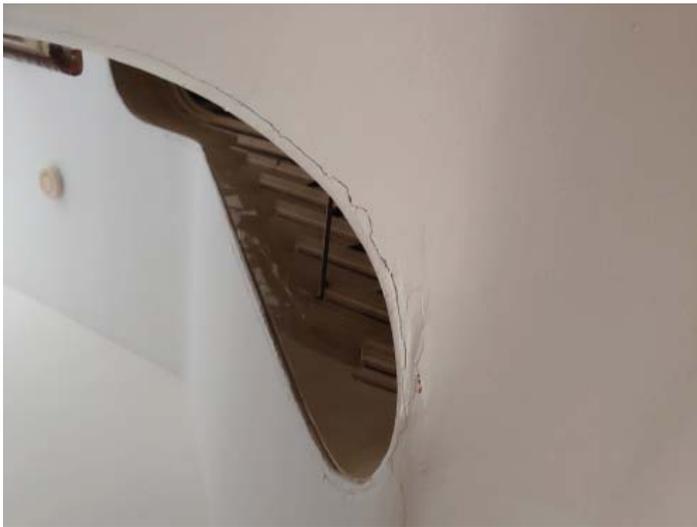
Photo 34
Photo at the second floor.
Repair and repaint at
cracked underside of the
winding stairs.

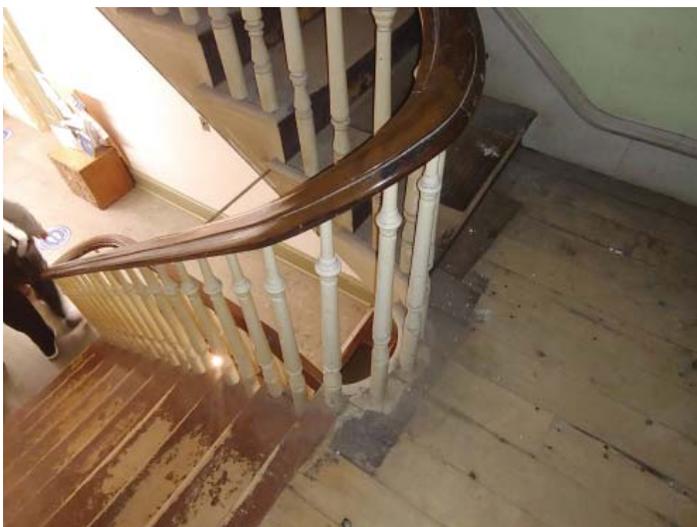
Photo 35
Photo taken at Stair Landing
320. Repair the stair tread
finishes and add floor
finishes to the landing.

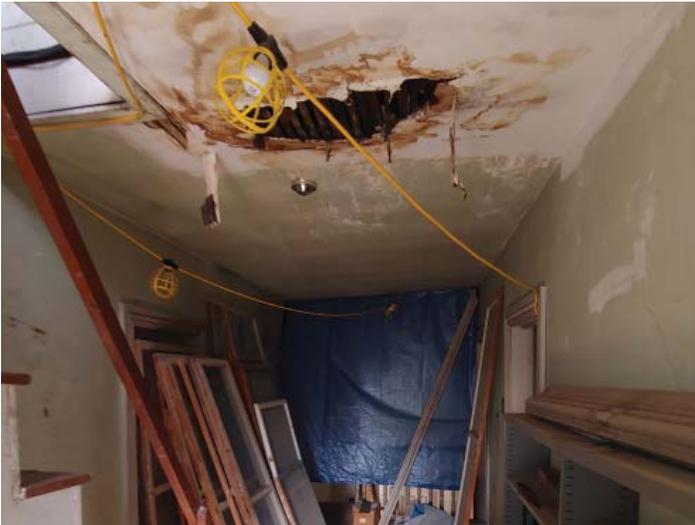
Photo 39
The building needs to be waterproof and the water damage to the third floor ceiling at Hall 310 needs to be repaired.

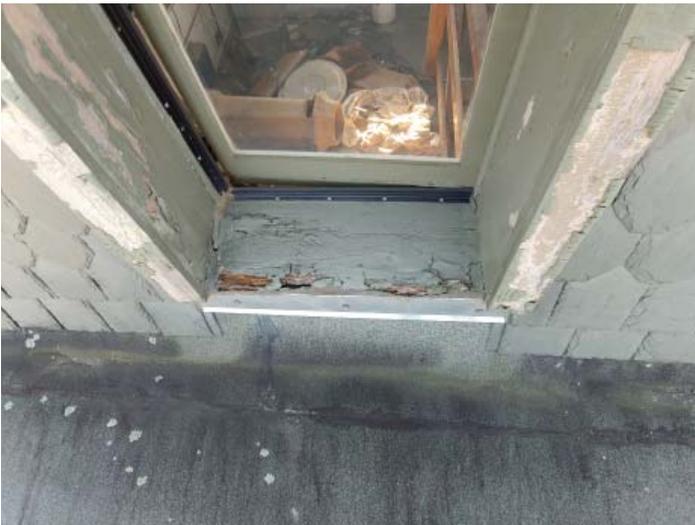
Photo 40
Photo is towards the cupola from the outside roof. The sill and trim needs to be repaired and repainted. The door needs to be watertight. The path to the door at the cupola interior needs to be cleared. The roof appears to slope towards the cupola instead to the perimeter drains that will continue to cause the potential of water infiltration around the cupola. The roof should slope away from the cupola.

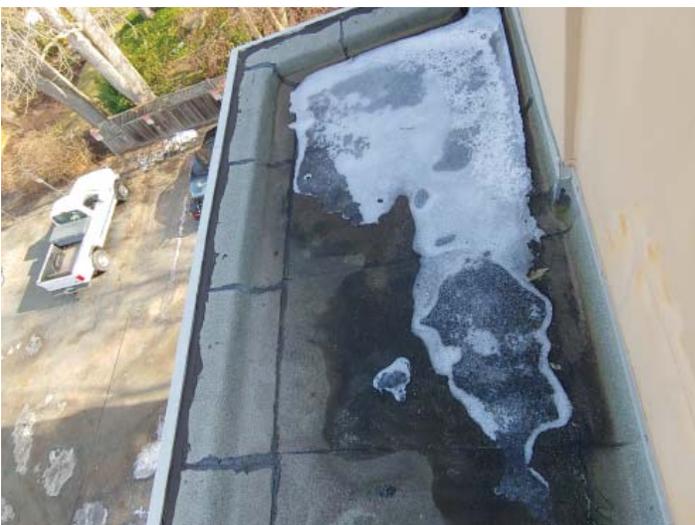
Photo 41
Frozen ponding water in on the roof is evidence that the roof drainage system needs to be cleaned.

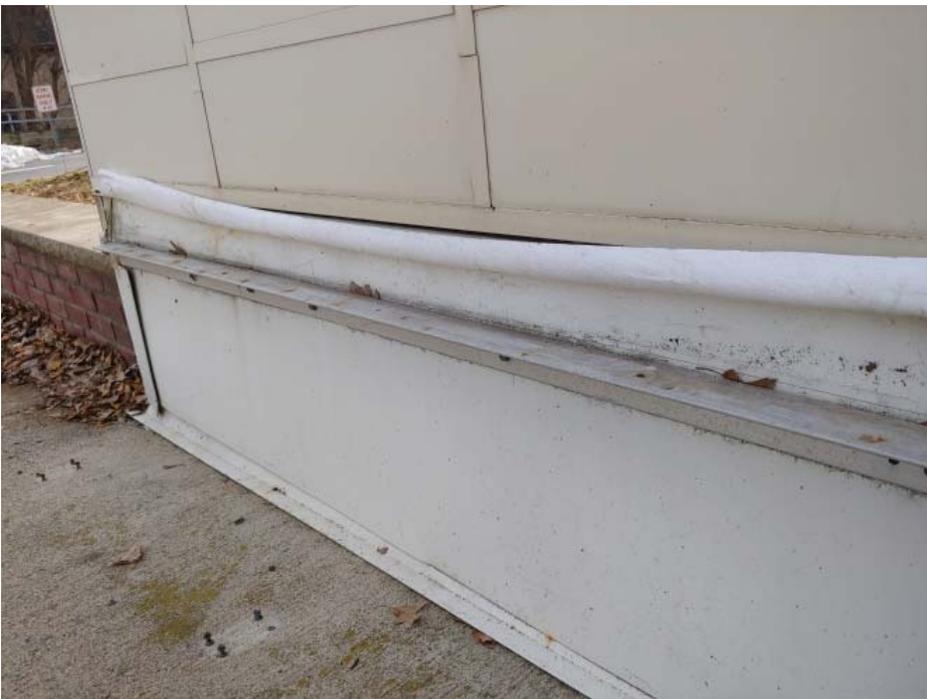
Photo 4
Trim missing over
waterproofing at front
(east) facade

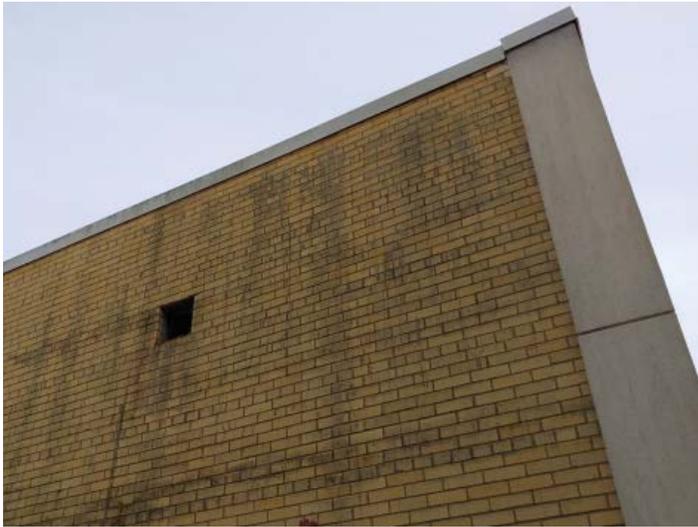
Photo 7
Patch masonry opening
on side (north) facade

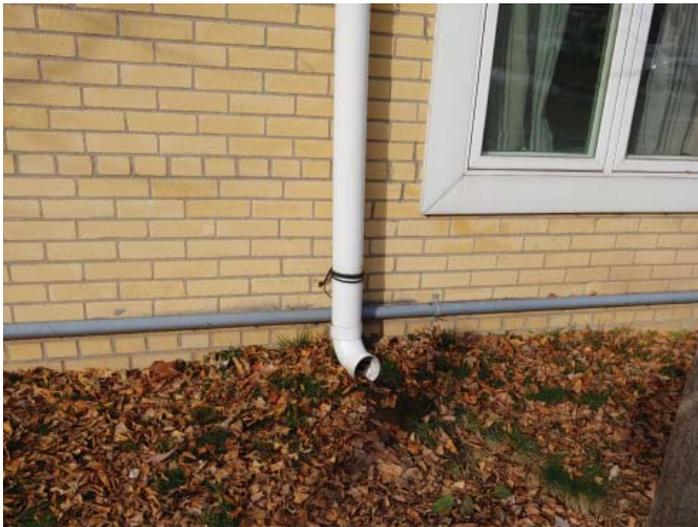
Photo 8
Install splash block under rain
leader and attach to building with
weather resistant metal brackets

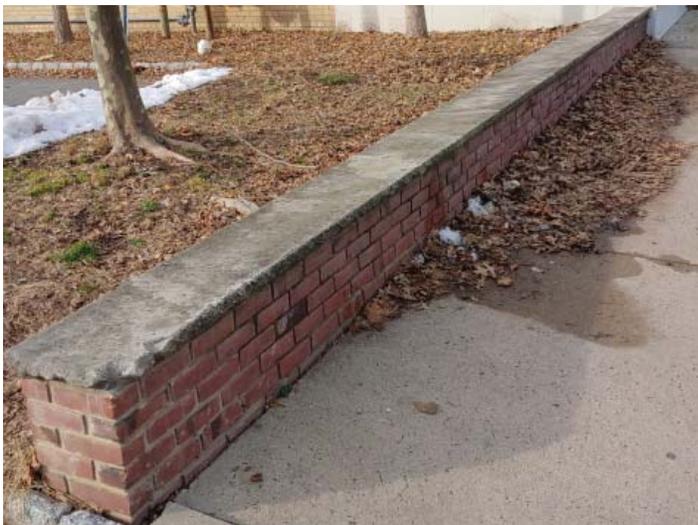
Photo 9
Clean and repoint
masonry wall along
sidewalk.

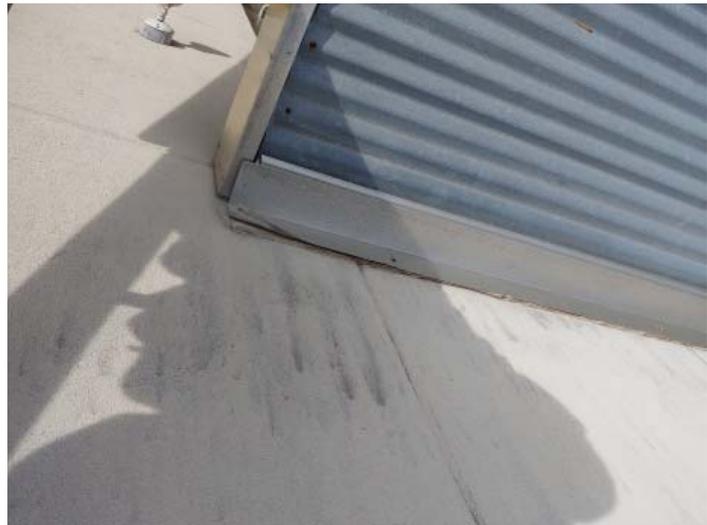
Photo 12
Clean roof

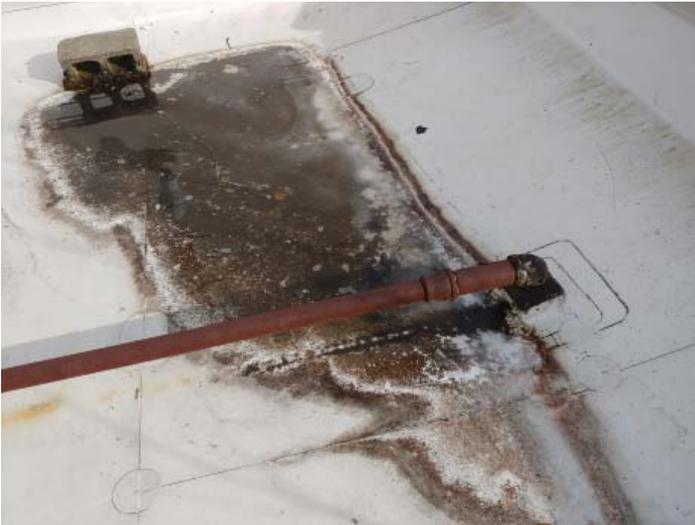
Photo 13
Clean roof, remove
concrete masonry unit,
repaint pipe located
upon the roof

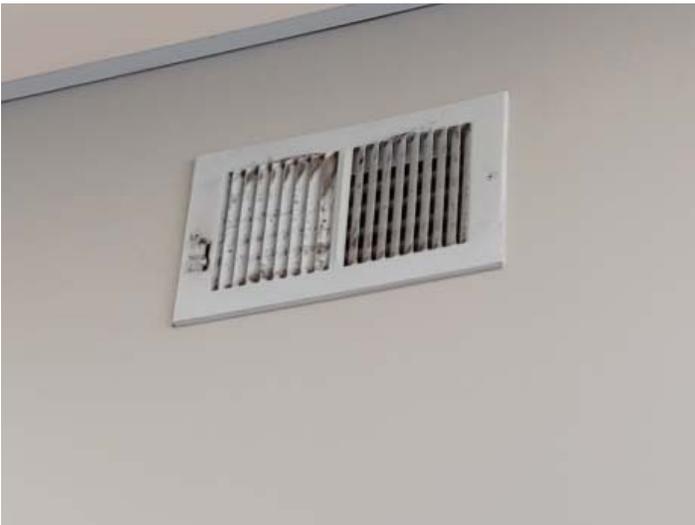
Photo 14
Wall and ceiling air grilles
need to be cleaned
throughout the building

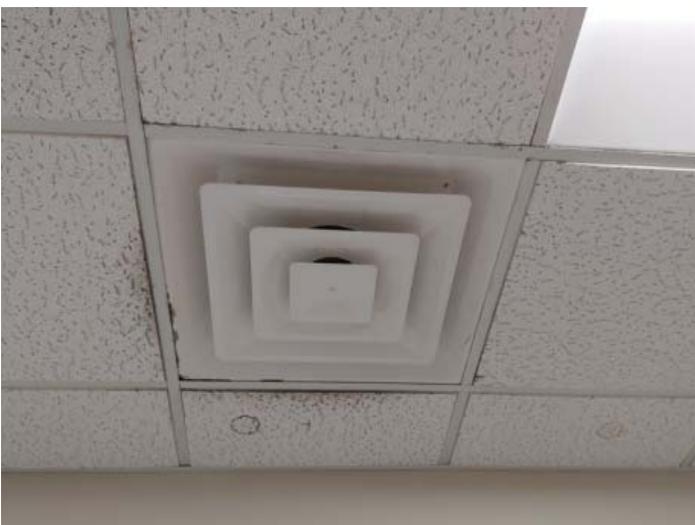
Photo 15
Ceiling air grilles need to
be cleaned throughout the
building

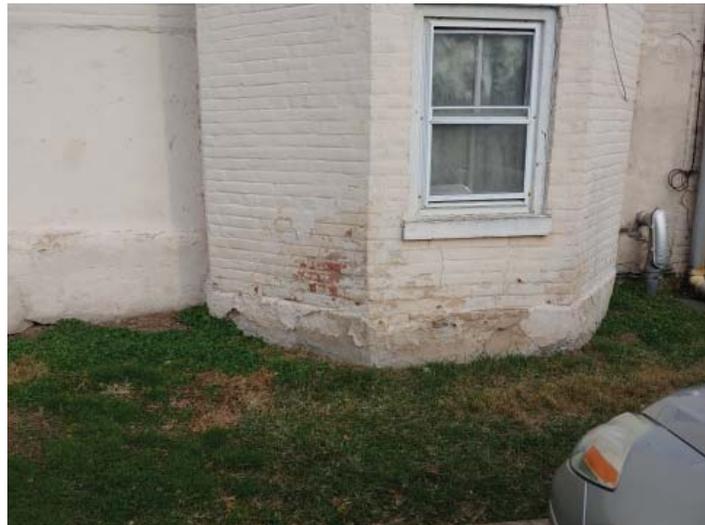
Photo 7

Photo is towards the west façade and shows the window that needs to be replaced with an insulated window, trim to be painted, brick to be repointed and painted.

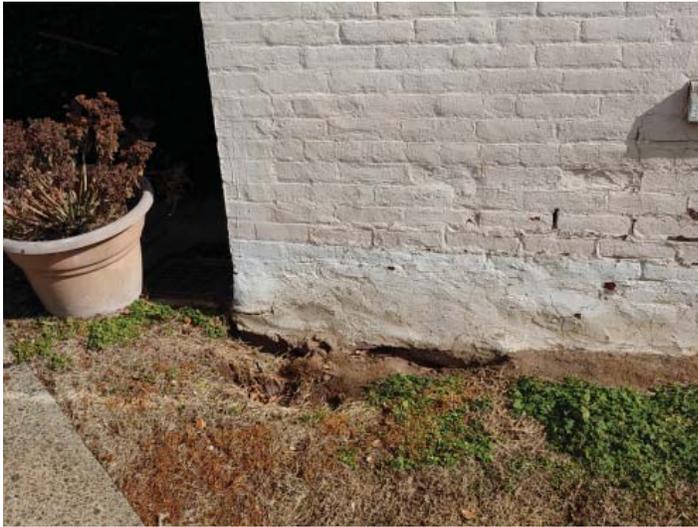
Photo 8
Repair erosion under the
corner of the building along
the west façade.

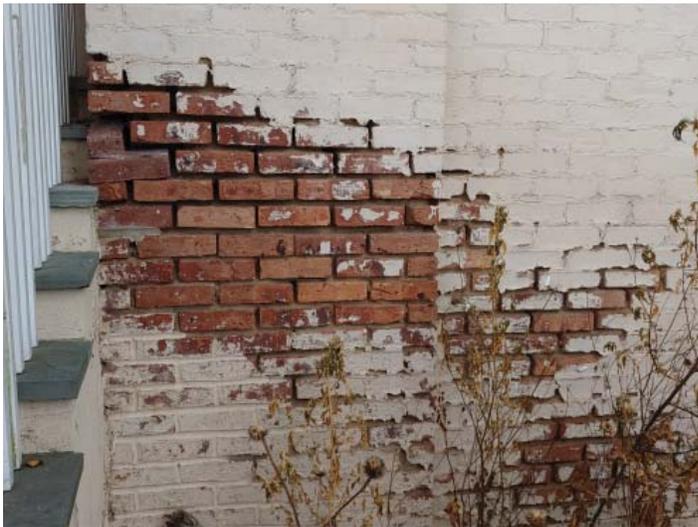
Photo 9
Repoint and repaint brick
on the west wall and near
the stairs to the front
entrance. Repaint the
columns above.

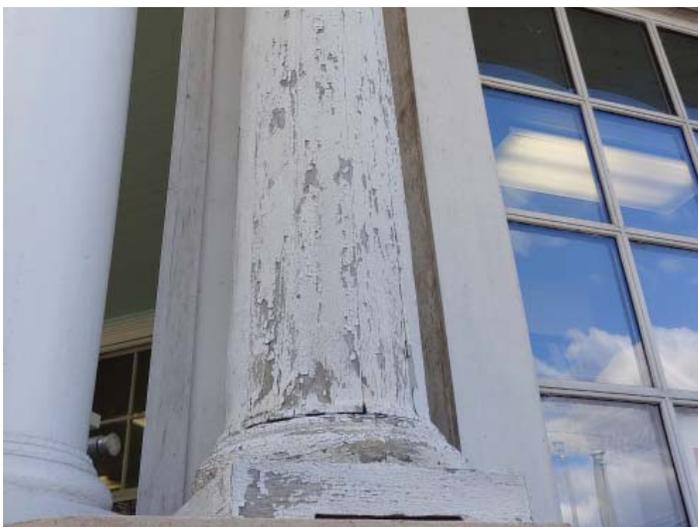
Photo 10
Repaint the columns near
the front entrance and
around to part of the east
façade.

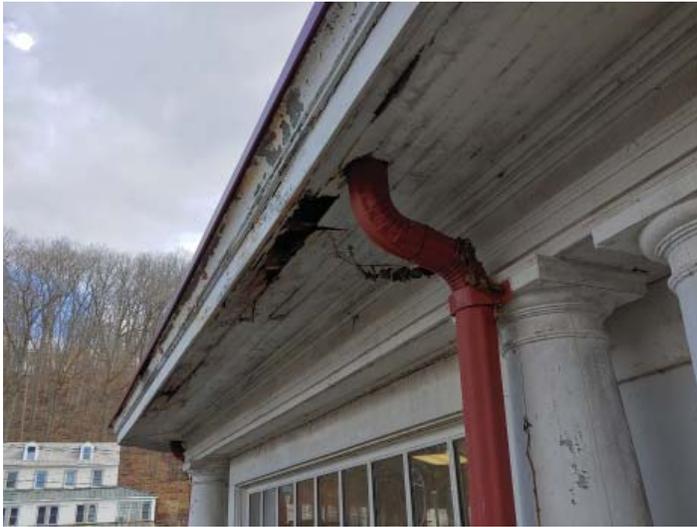
Photo 14
Photo at the northeast corner of the building. Repair cracks on the columns and repaint. Repair wood soffit and repaint. Seal around the penetration of the leader at the soffit. Paint exterior surfaces.

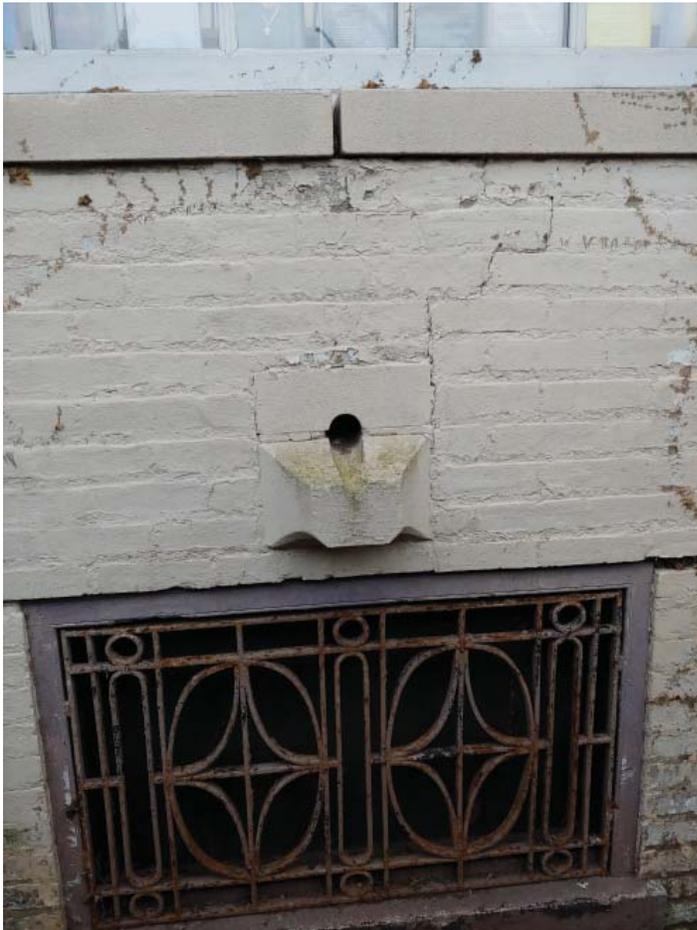
Photo 15
Photo at the northeast corner of the building. Repoint brick and at open joints of the cast stone window sill. Remove organic growth on the building. Repaint the windows, brick, and grille.

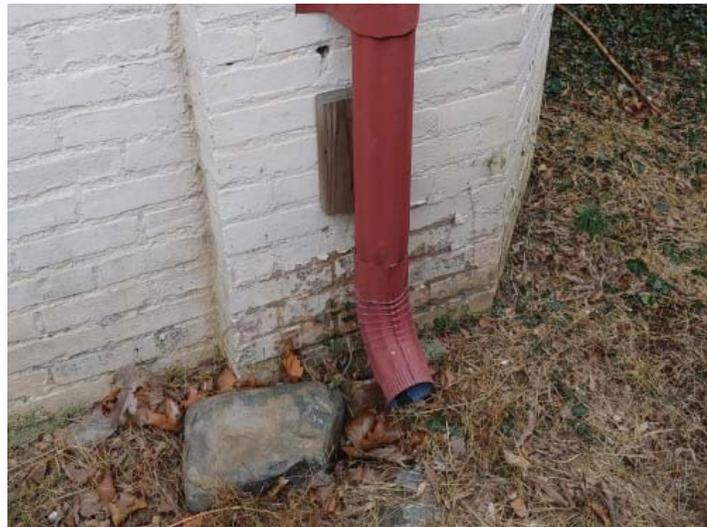
Photo 17
Remove organic growth on the building. Repoint and repaint brick. Clean out underground drain pipe. Connect rain leader to the underground drain pipe with a boot covered over the joint.

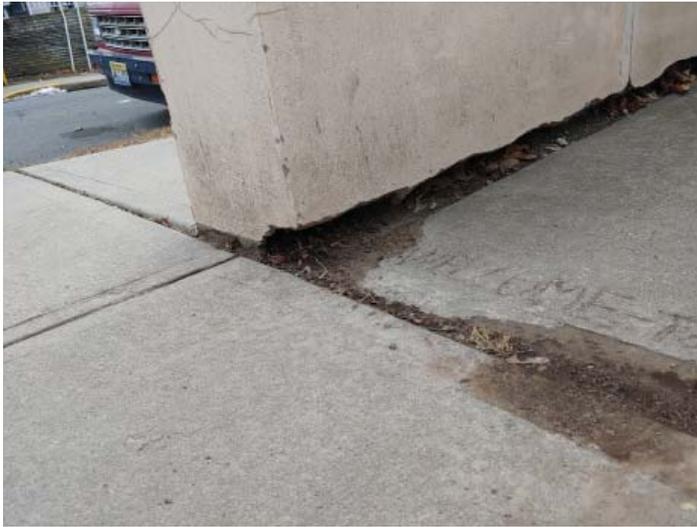
Photo 19
Repair low wall cracks and repaint at the handicapped ramp at the southeast side of the building. Remove the dirt at the ramp and seal between the sidewalk and ramp without a rise or drop more than 1/2" to be handicapped accessible.

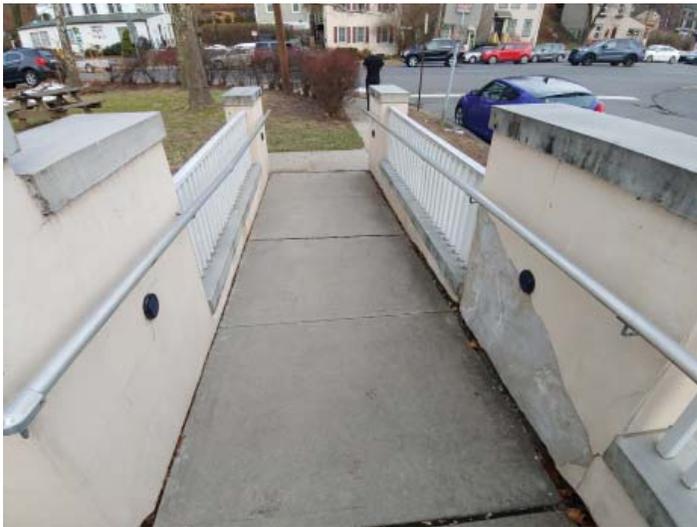
Photo 20
Repair the side walls of the handicapped ramp. Replace the sconce lights with LED. Fill open joints along the concrete ramp.

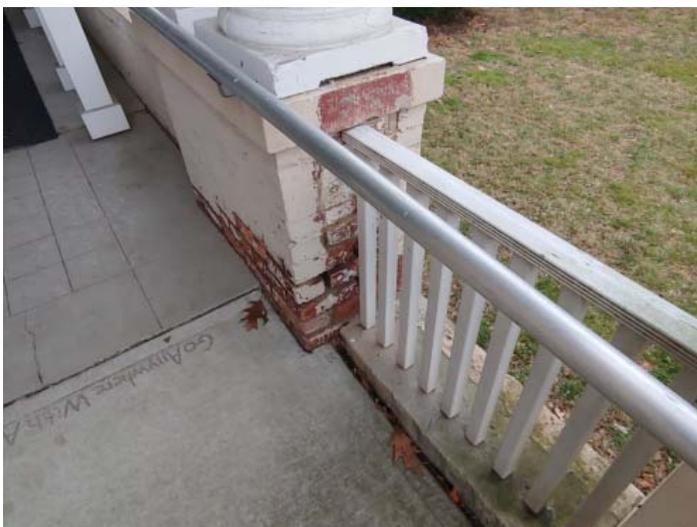
Photo 21
Remove organic growth on the building. Repoint and repaint brick. Repaint guardrail, spindles, and columns.

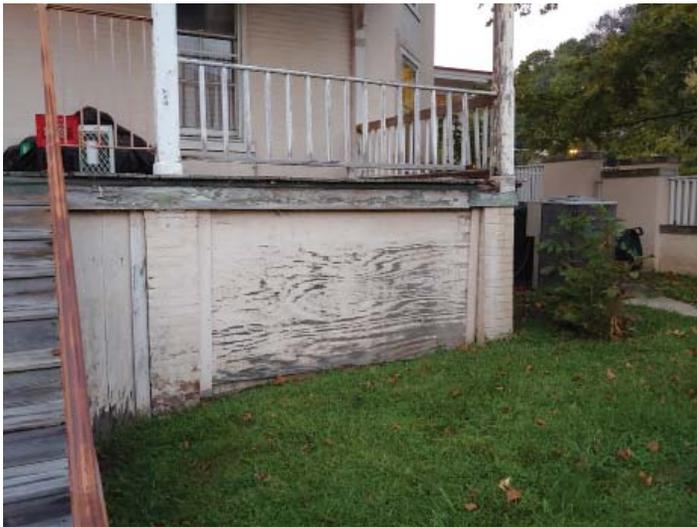
Photo 26
Photo of the back porch. Replace damaged guardrail, wooden planks at the porch, support of the porch floor, and guardrail. Paint all surfaces. Replace window with an insulated window.

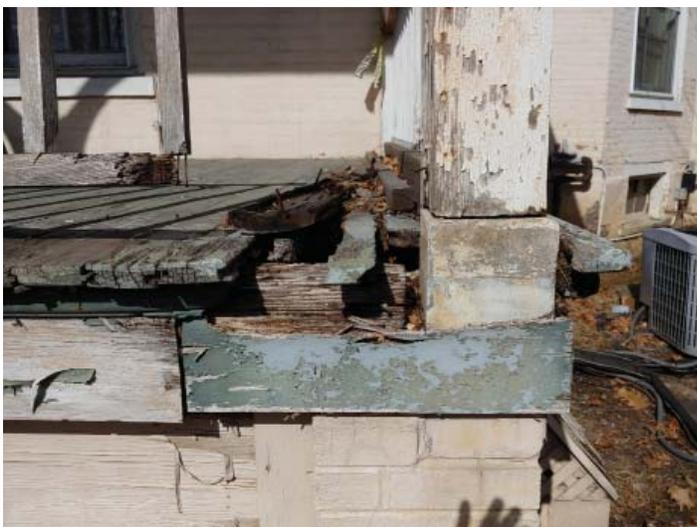
Photo 27
Photo of the back porch. Replace damaged guardrail, wooden planks at the porch, support of the porch floor, and guardrail. Paint all surfaces.

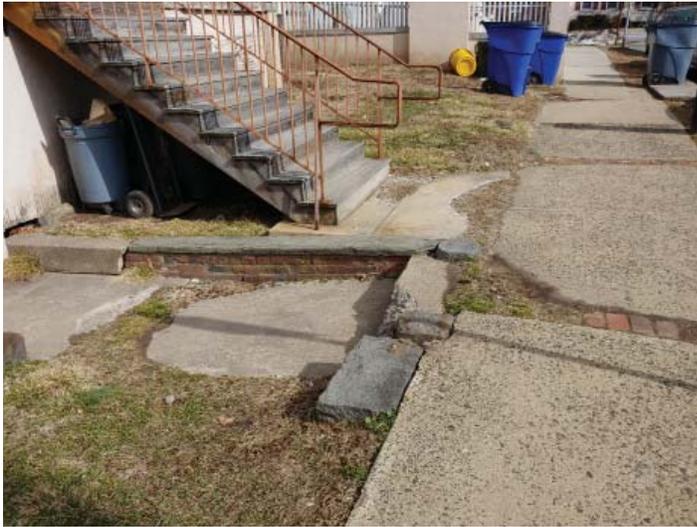
Photo 31
Replace concrete sidewalk.
Repoint brick. Replace
deteriorated stone cap
over low brick wall. See
comments to other photos of
the stairs to the back porch.

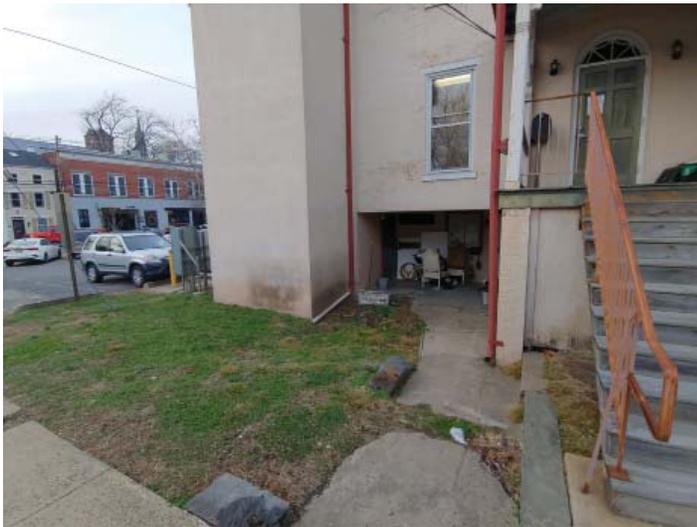
Photo 32
Photo towards the exterior entrance
to the basement residential
apartment and storage area. The
residential apartment was not
visited for the scope of this report.
Remove organic growth from the
building. Remove clutter from the
area under the building that leads
to the entrances to the residential
apartment and to the storage areas.
Replace the concrete sidewalk to the
basement. Install splash blocks under
the rail leaders. Replace windows.
Repaint brick.

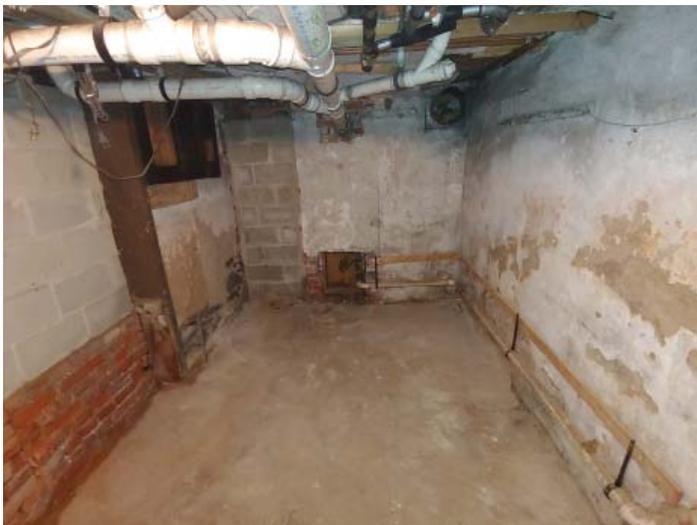
Photo 33
Unfinished basement. Install
insulation in ceiling.

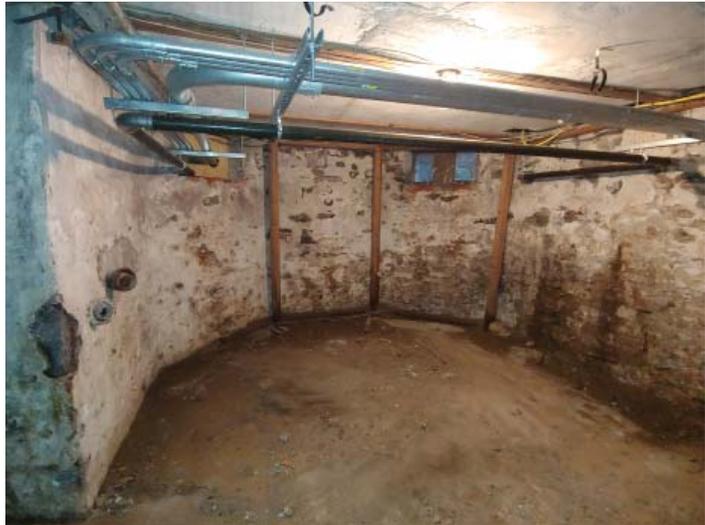
Photo 35
Unfinished basement.
Patch opening and Install
insulation in ceiling. Replace
deteriorated conduits and
junction boxes.

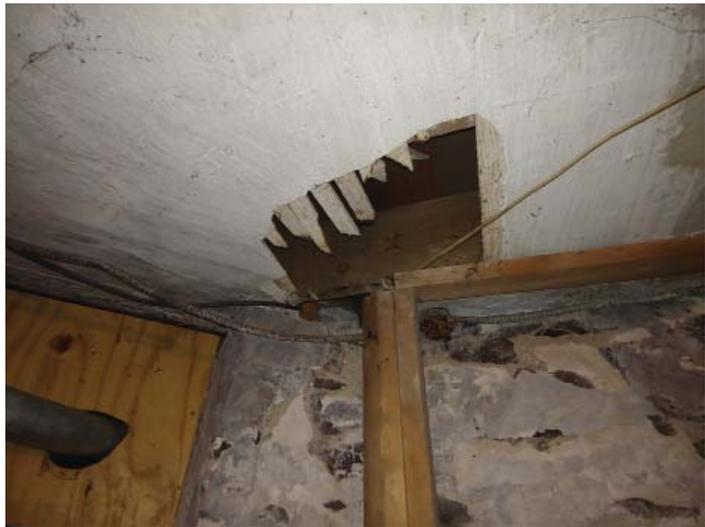
Photo 36
Unfinished basement. Install
insulation in ceiling. Remove
debris and clean spaces.

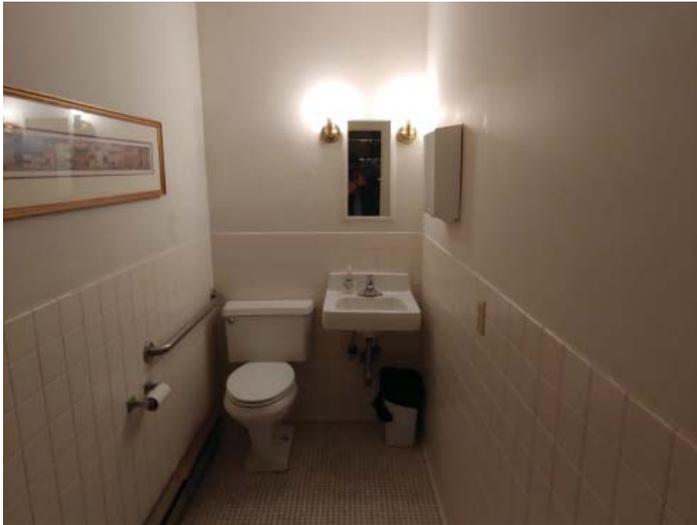
Photo 37
Water closet at the first floor Toilet 110 is not handicapped compliant. It is missing the vertical grab bar at the side wall and horizontal grab bar at back wall. It is not dimensionally compliant for handicapped accessibility. Replace lights with LED light fixtures with sensor controls. Install toilet accessories to the handicapped accessible heights.

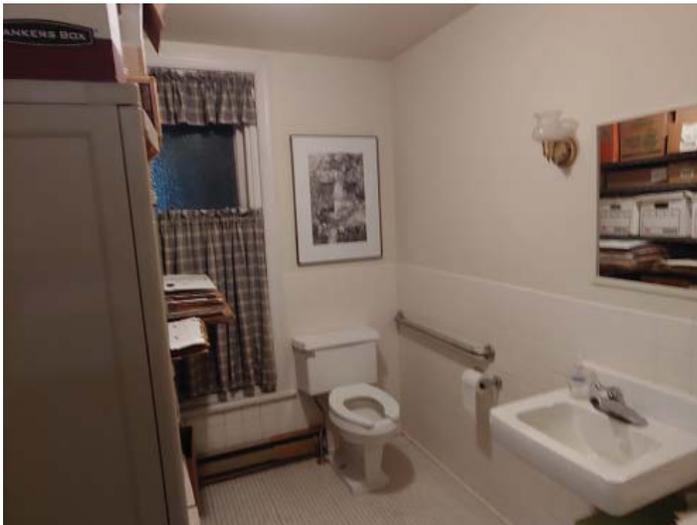
Photo 38
Water closet at the first floor Toilet 109 is not handicapped compliant. It is missing the vertical grab bar at the side wall and horizontal grab bar at back wall. Replace lights with LED light fixtures with sensor controls. Install toilet accessories to the handicapped accessible heights.

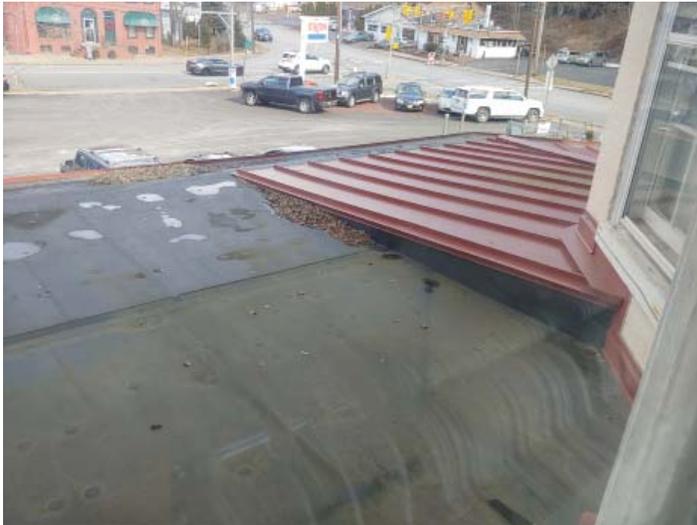
Photo 43
Clean roof and drainage paths of debris
