CITY OF LAMBERTVILLE
HUNTERDON COUNTY

ARCHITECTURAL REPORT SUMMARY CITY OF LAMBERTVILLE

EXECUTIVE SUMMARY

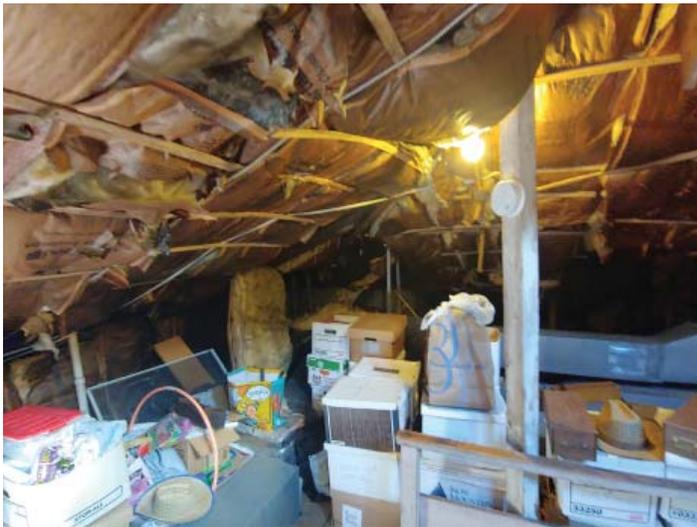
Photo 44
Photo in the roof. The existing structure is probably not designed to support the load of file boxes of paper. Refer to the structural engineer's report. Replace damaged insulation. Replace light fixtures with LED light fixtures.

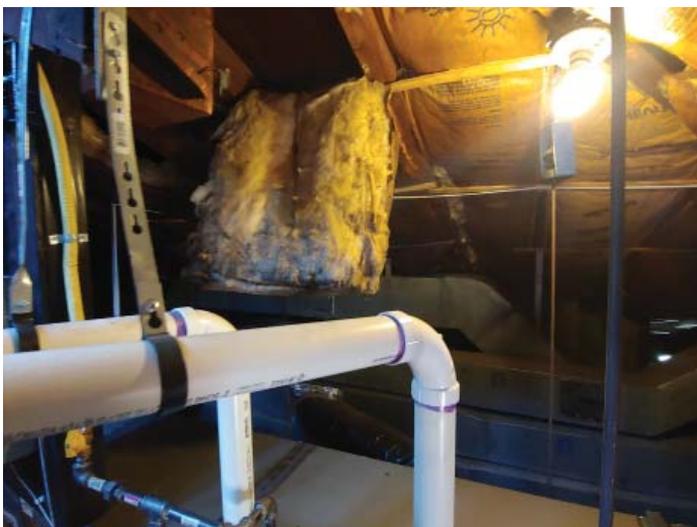
Photo 45
Photo in the roof. Replace damaged insulation. Replace light fixtures with LED light fixtures.

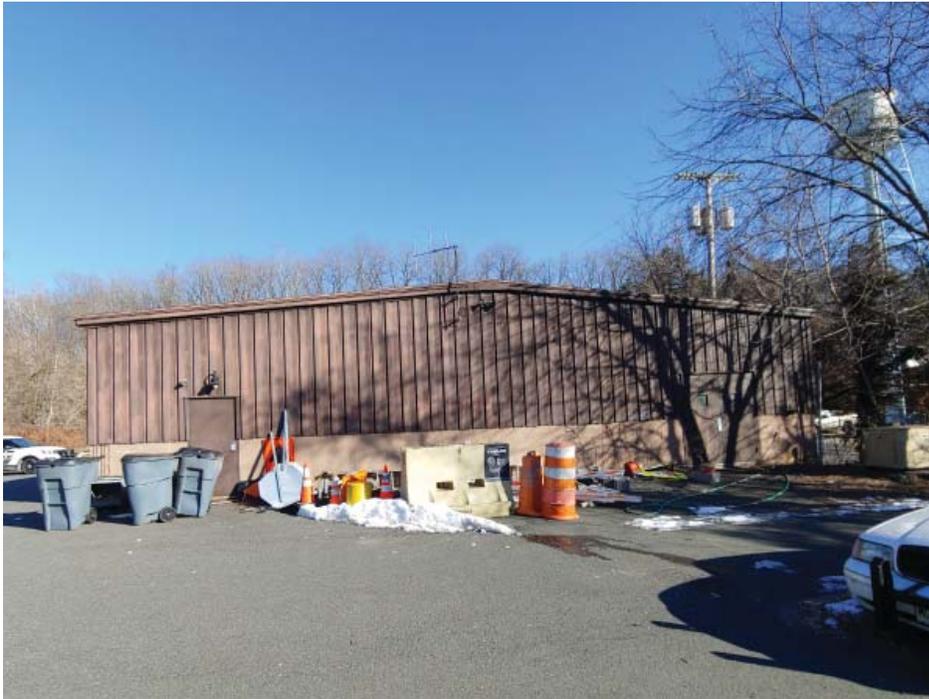
Photo 4
West façade. Repaint the metal siding and doors all around the building. Replace exterior lighting with LED lighting fixtures.

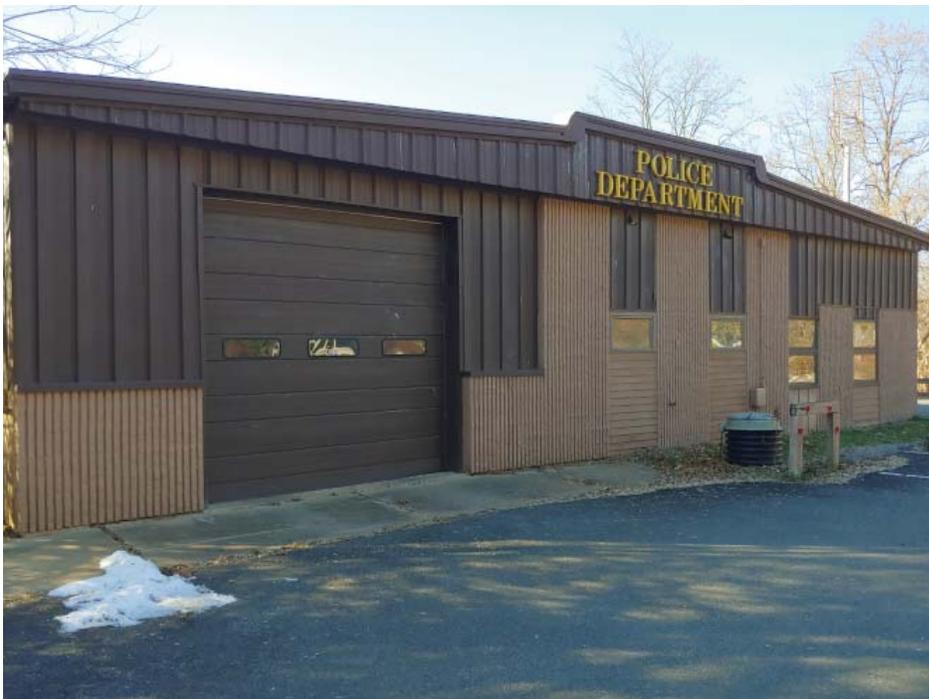
Photo 5
East façade along N. Main Street. Repaint the metal siding and doors all around the building. Repair and repaint wood siding. Remove bird nest, clean bird debris, and repaint.

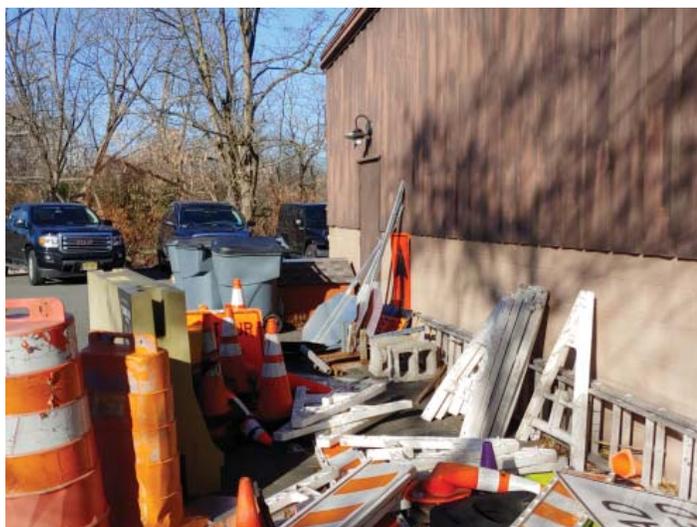
Photo 7
Replace threshold at double doors to be weather tight.

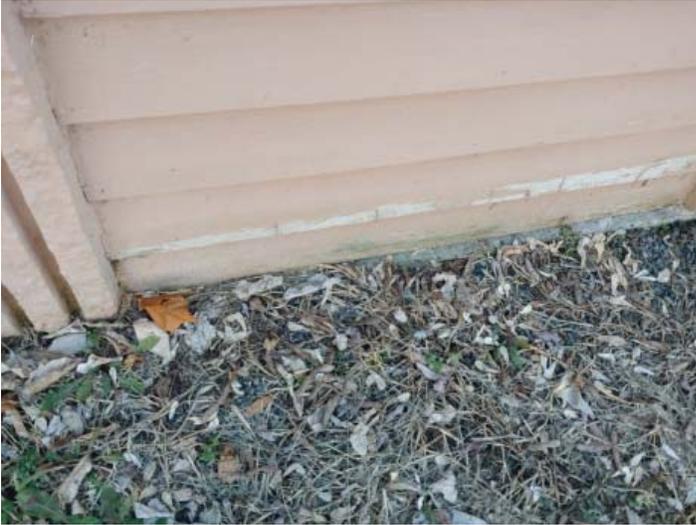
Photo 9
East façade. Repair and
repaint wood siding.

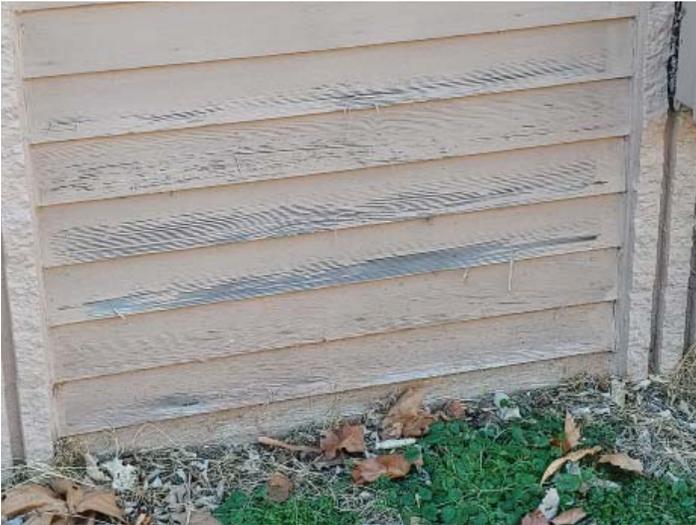
Photo 10
East façade. Repair and
repaint wood siding.

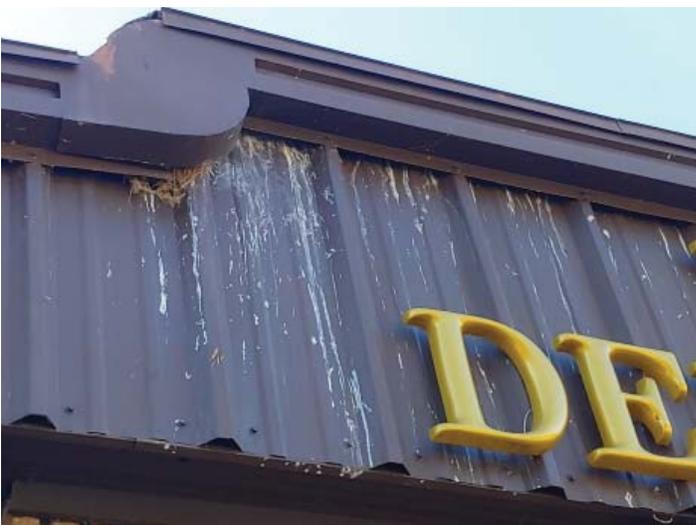
Photo 11
Remove bird nest, clean bird
debris, and repaint at east
facade.

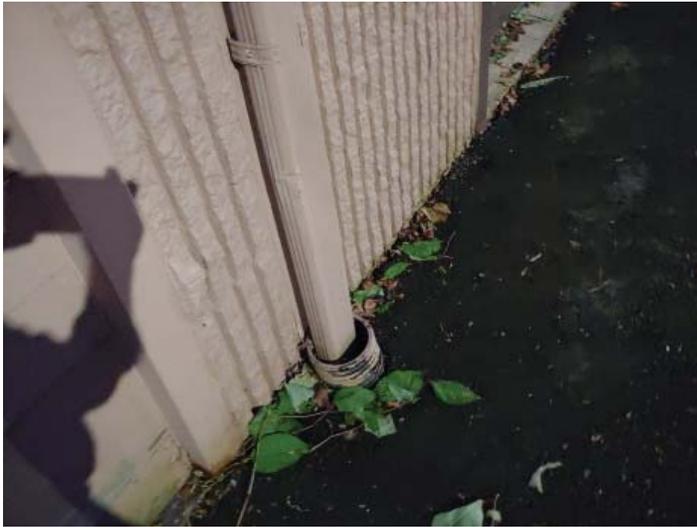
Photo 15
Install boot around joint between rain leader and underground drain after cleaning underground drain from any debris along north façade.

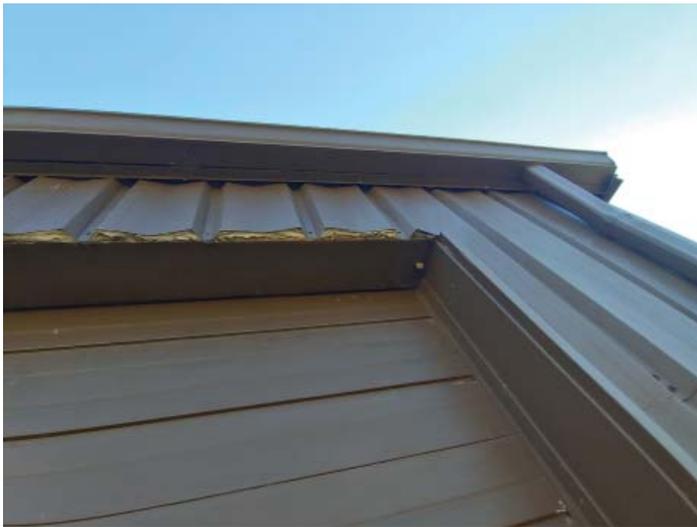
Photo 16
Photo is along the north façade. Exposed insulation behind metal siding should be covered with a metal trim.

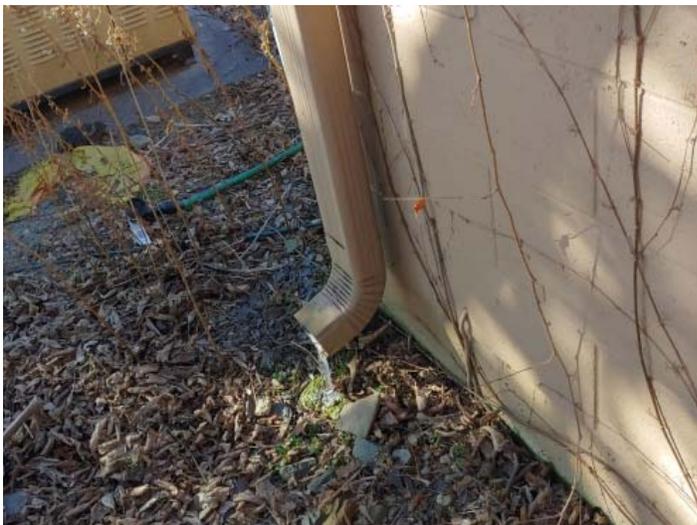
Photo 17
Rain leader at the south façade is missing a splash block.

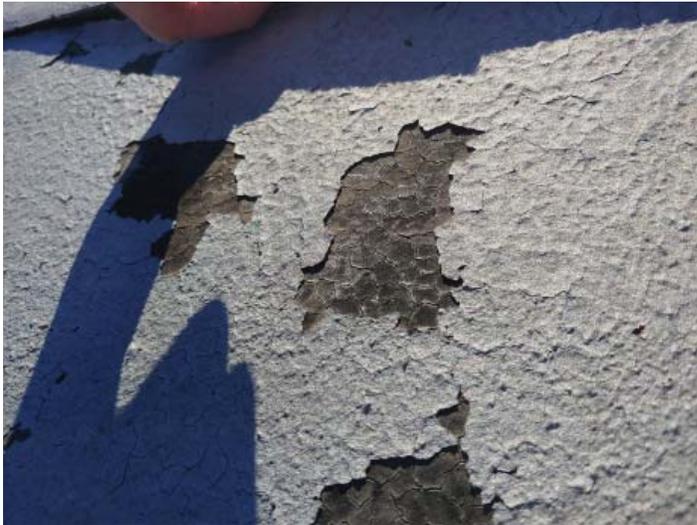
Photo 21
The roof membrane has an aluminum coating that is coming off in areas and needs to be repaired.

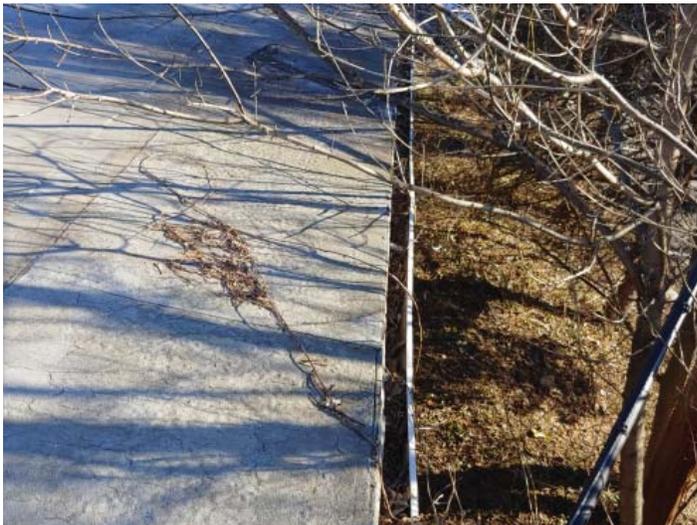
Photo 22
Trim tree that sheds its debris upon the roof and into the gutters. Clean gutters.

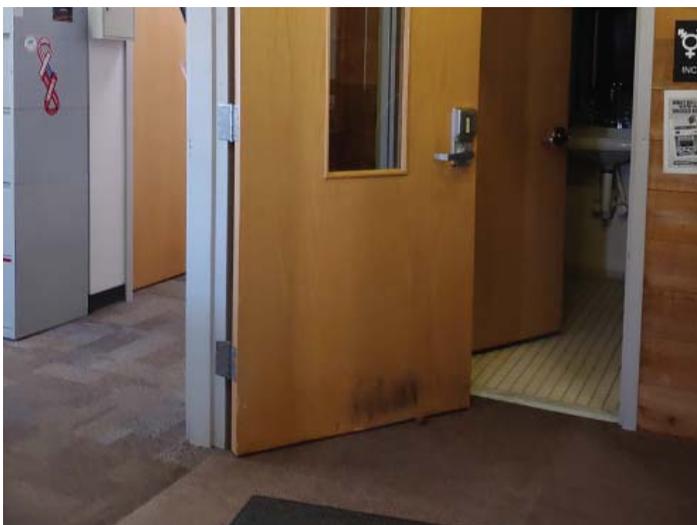
Photo 23
Doors in the Lobby 006 are scuffed. They should be refinished and have kick plates installed.

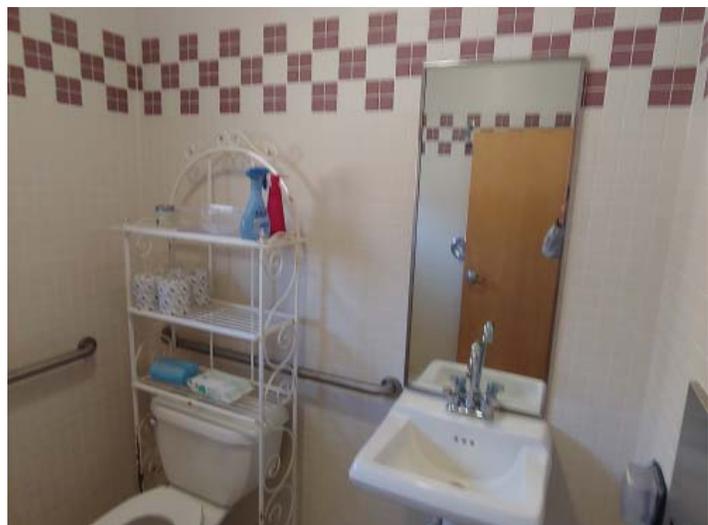
Photo 26
Women's Locker Room Toilet
003A is missing a vertical grab
bar at the side wall of the water
closet. Shelving unit is blocking
the back grab bar. Replace
lighting with LED lights.

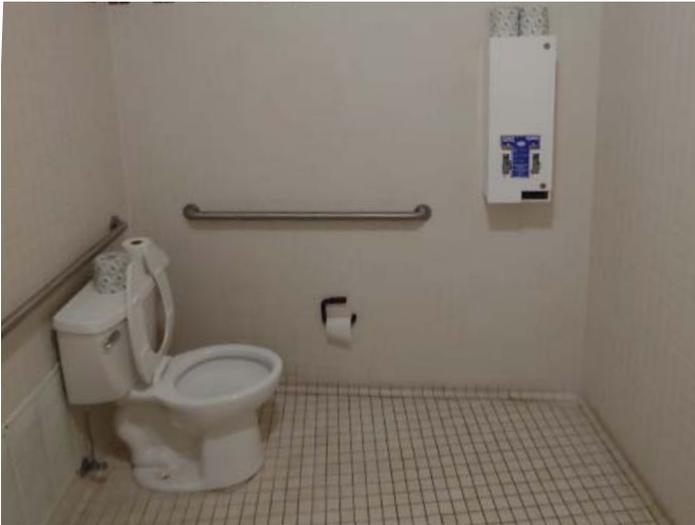
Photo 27
Toilet 007 is missing a vertical grab bar at the side wall of the water closet. Replace lighting with LED lights.

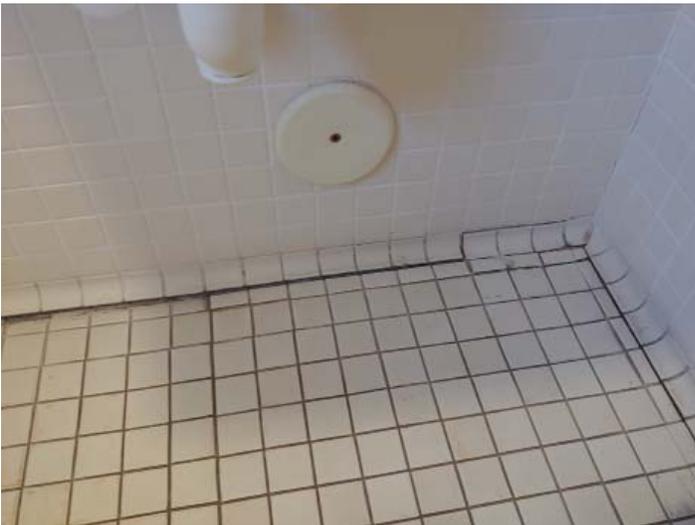
Photo 28
Tiled floor is cracked and separating in the Women's Locker Room Toilet 003A due to deflection in the floor slab. Refer to the structural engineer's report. Floor and tile to be repaired.

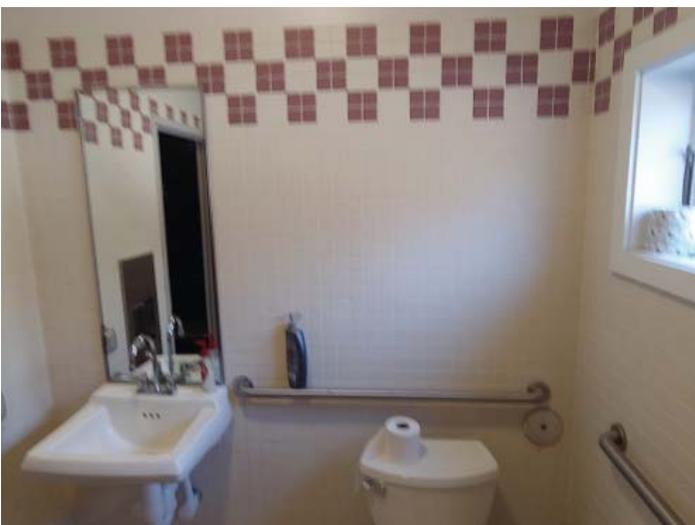
Photo 29
Men's Locker Room Toilet 004A is missing a vertical grab bar at the side wall of the water closet. Replace lighting with LED lights.

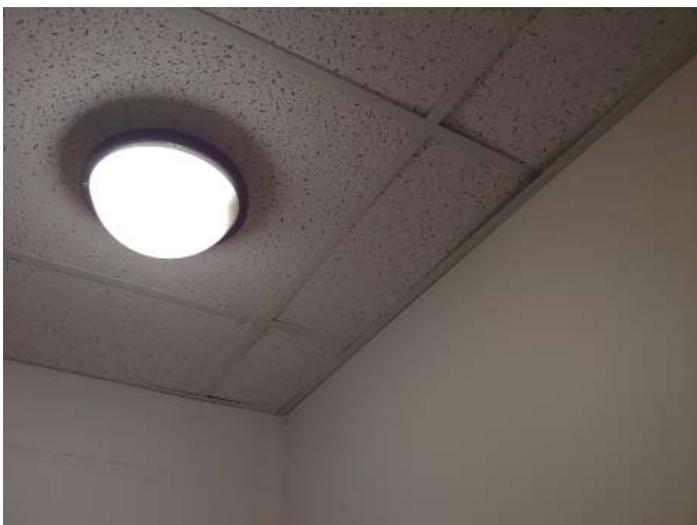
Photo 35
Typical surface mounted dome compact fluorescent light fixture throughout the building that should be replaced with LED light fixtures. Note that some of the ceiling tile needs to be reinserted into the grid.

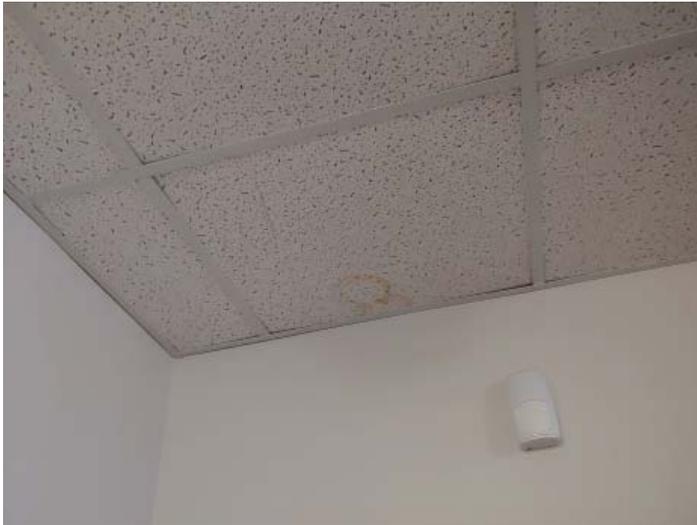
Photo 38
Repair water leak and
replace water damaged
ceiling tile in Hall 010A.

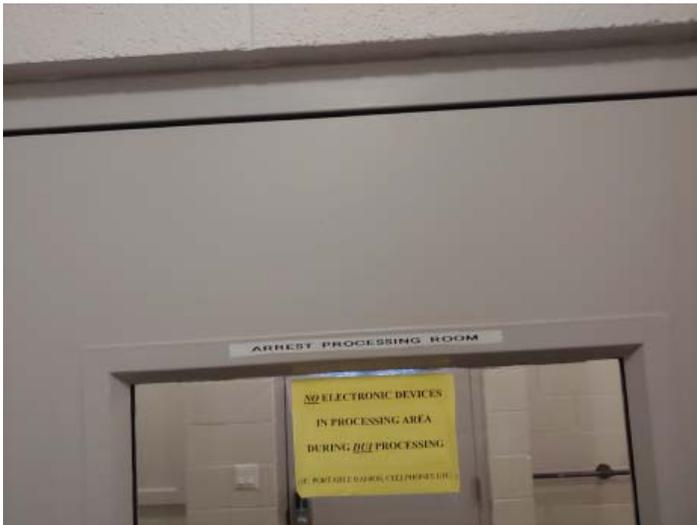
Photo 39
Room sign in Hall
010A on the window
frame of the door to
the Arrest Processing
009 room. This sign is
typical in other areas of
the building and is not
handicapped compliant
with proper mounting
height and braille.

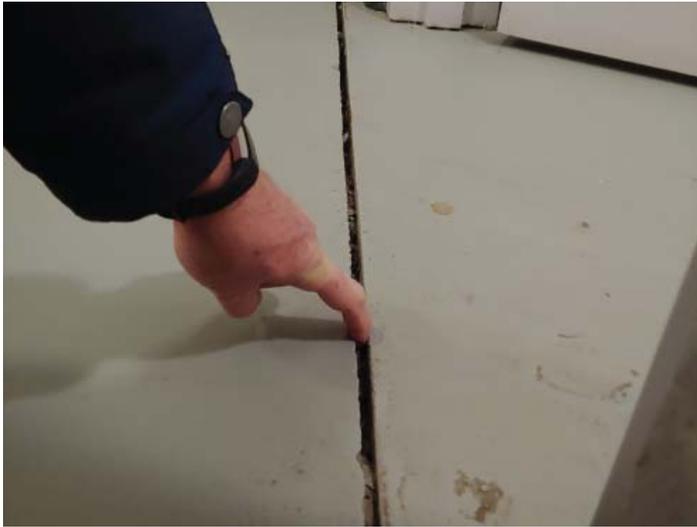
Photo 44
Repair slab settling in
the Arrest Processing
009 room. See structural
engineer's report. Repair
and fill joint in slab.

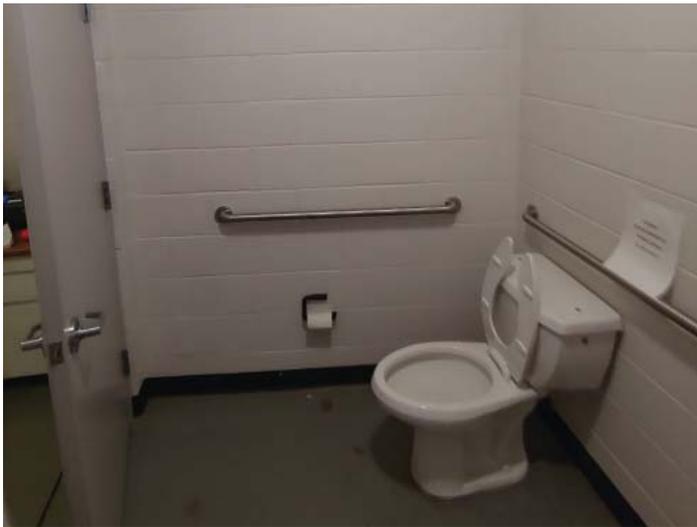
Photo 45
Toilet 008 is missing a vertical
grab bar at the side wall of
the water closet. Replace
lighting with LED lights.
Replace plastic residential
toilet paper holder with metal
commercial grade toilet paper
holder for more durability and
ease of maintenance.

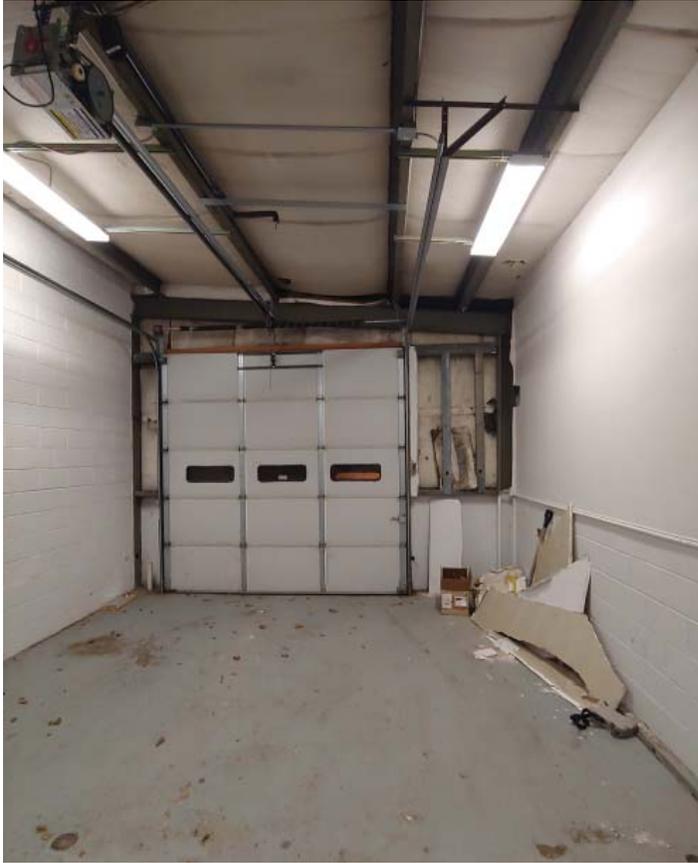
Photo 50
Repair wall with new insulation
and GWB near overhead door
in the Sally Port 005. Repaint
concrete floor.

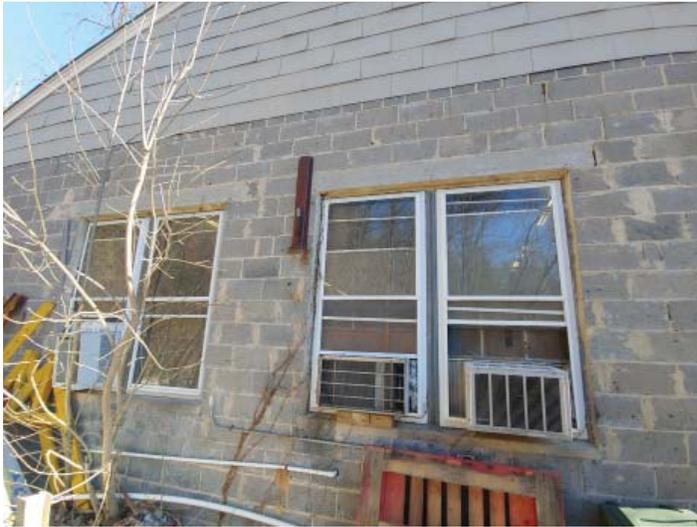
Photo 5
South façade of the building. Windows with storm windows should be replaced with windows with tempered insulated glass. CMU wall needs to be repointed. Replace insulation around air conditioning units. Seal around all wall penetrations.

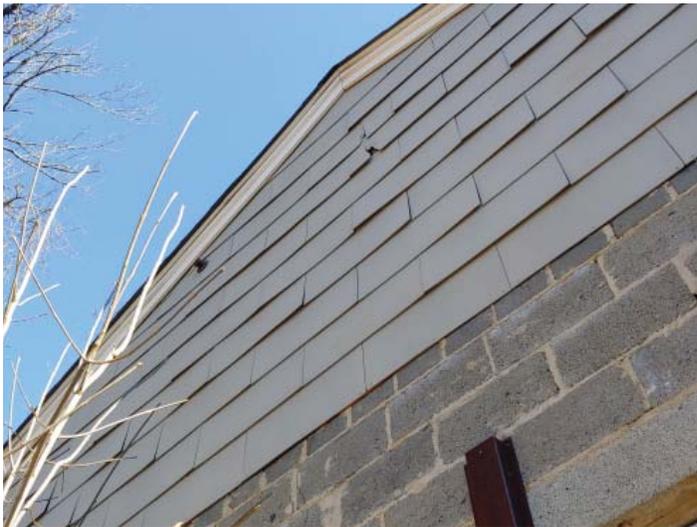
Photo 6
Repair damaged siding at gable at the south façade.

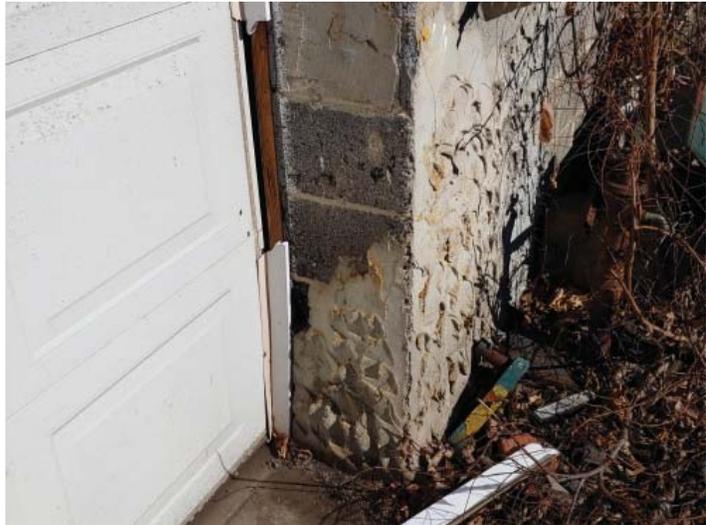
Photo 9
Install new insulation around
the air conditioning unit at the
east façade.

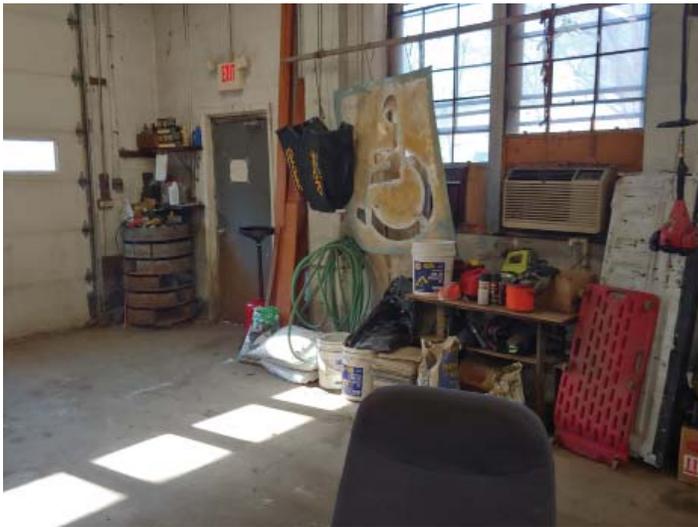
Photo 12
Garage Room 001 looking
towards the southeast.
Replace hollow metal
door and frame. Replace
all windows tempered
insulated glass. Repair
CMU wall.

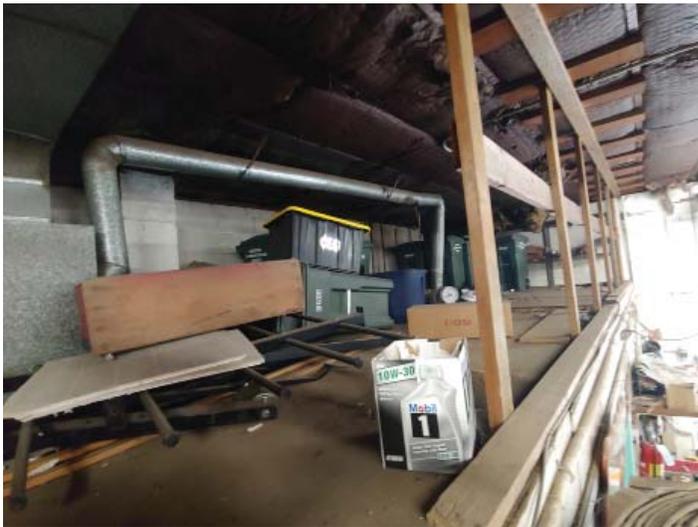
Photo 18
Mezzanine in the Garage Room 001. Provide guardrails that will not allow a 21 inch sphere to pass through the spindles per IBC NJ 1015.4.

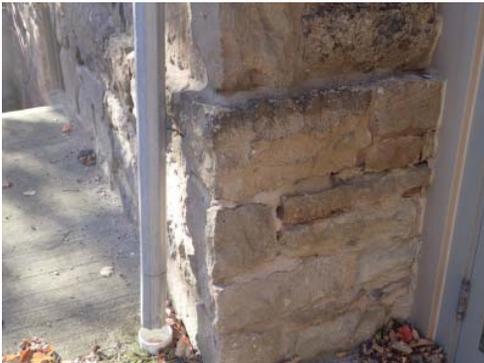
The stone masonry on the exterior walls is in fair condition. Several cracks were observed in the mortar joints and also at the water table and at doors and windows. Cracks were observed around the cast stone water table and concrete base at the elevator addition.

Photo CH1 Cracking in exterior wall

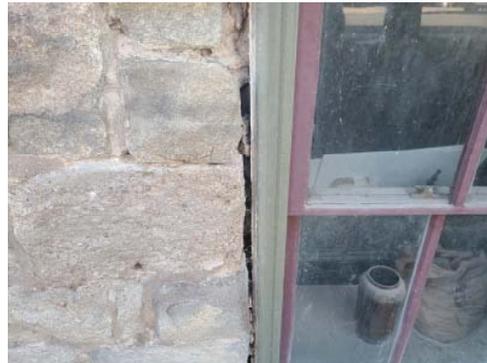
Photo CH2 Separation of window frames from masonry

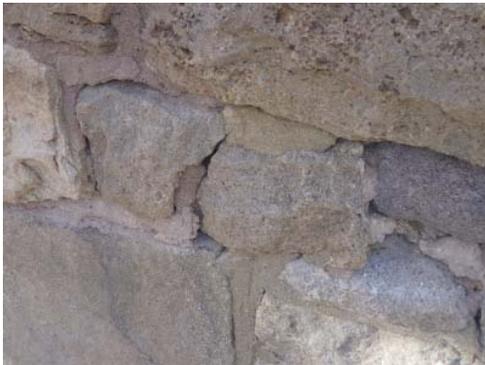
Photo CH3 Deterioration in exterior stone masonry cladding

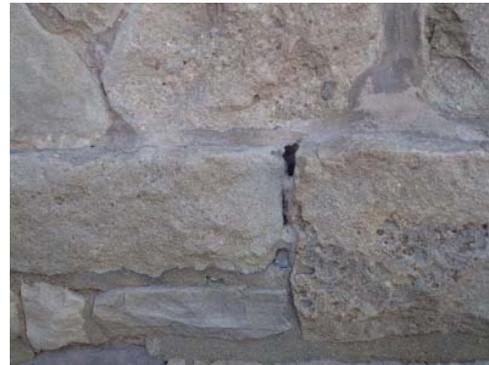
Photo CH4 Deterioration in exterior stone masonry cladding

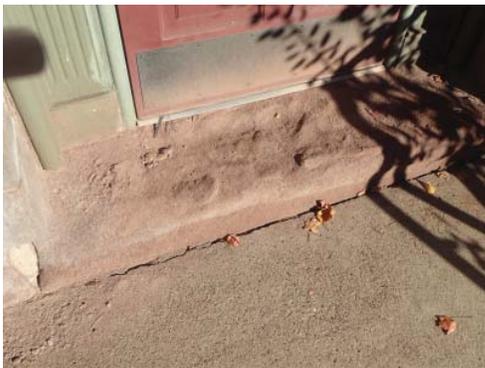
The front stair (on the south façade) is damaged and needs to be replaced. See photograph CH5 and 6 on this page. The stairs on the West façade to the basement are in fair condition. The railing on this stair needs to be replaced. The wood stairs on the north façade going to the basement have deteriorated and need to be replaced.

Photo CH5 Front stoop deterioration

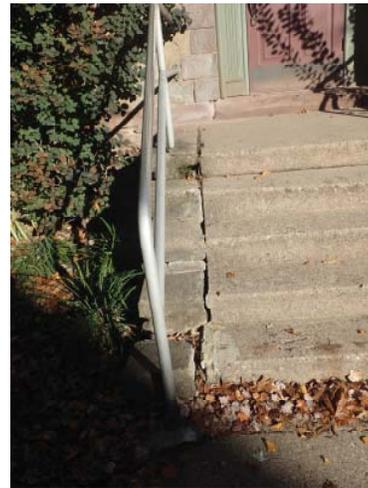
Photo CH6 Front Stair and railing deteriorated.

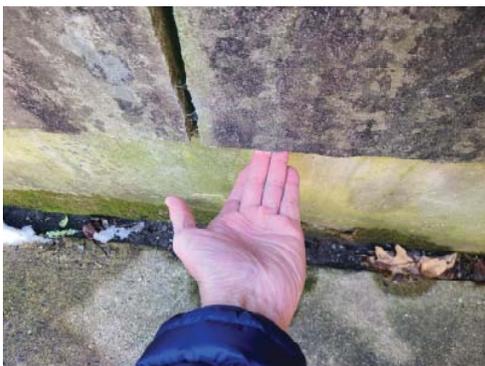
The areaway leading down to the basement has masonry walls which have failed. The water pressure on these walls have caused a shear failure and the cmu in each course has shifted horizontally from the cmu course below. See photograph CH7 and CH8 on this page.

Photo CH7 Failure of masonry wall at areaway

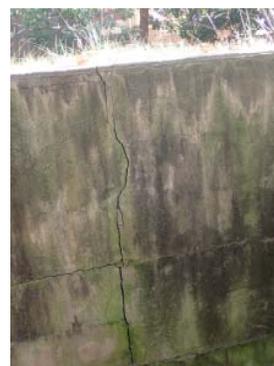
Photo CH8 Cracking in masonry wall at areaway

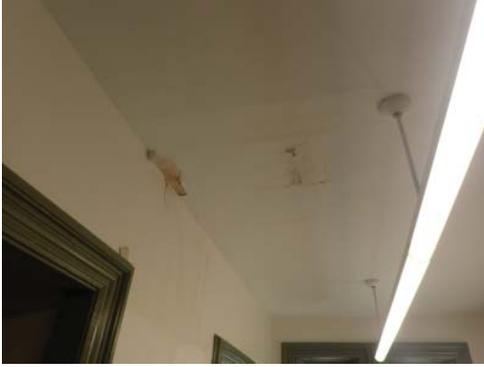
See photo CH 9 and 10 on page 145 for cracking in plaster at second floor.

Photo CH9 Cracking in plaster second floor ceiling

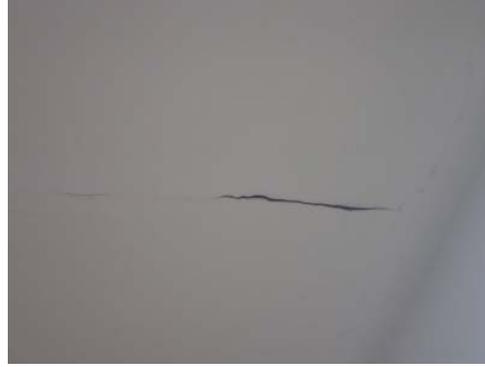
Photo CH10 Cracking in plaster second floor ceiling

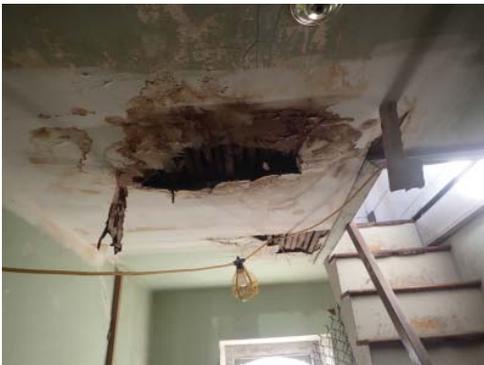
Where it could be observed, the condition of the floors and walls at the third floor is fair. This floor is unoccupied and is used for storage. The floor is level. There are several minor cracks in the wall and ceiling finishes at various locations. See photographs 15 to 18 on drawing A-103. Several walls have water damage from leaks at the roof. See photo CH11 and CH12 on this page. Approximate area to be patched is 150 square feet. These do not appear to be structural in nature. They have most likely been caused by water leaks. The newer elevator addition is in a good condition.

Photo CH11 Water damage failure of ceiling lath and plaster

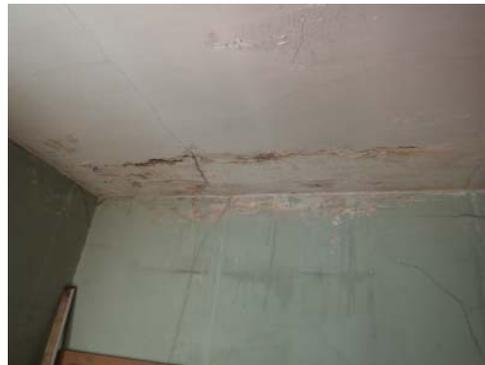
Photo CH12 Water damage failure of ceiling lath and plaster

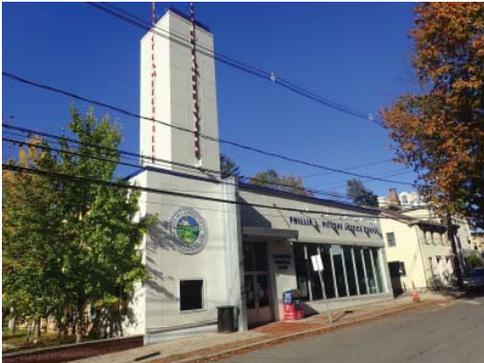
Photo JC 1 Front (East) View of the Justice Center

- 1) The knee wall at the front elevation on Union St and the glazing must be re-evaluated for water pressure from the design flood elevation based on item 1 above and flood ordinance in item 2 above. See photo JC1 and JC6 on page 150.

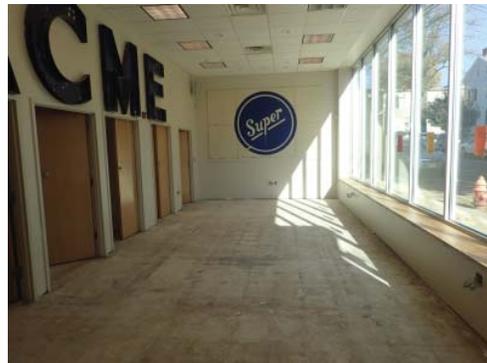
Photo JC 6 View of knee wall at the front.

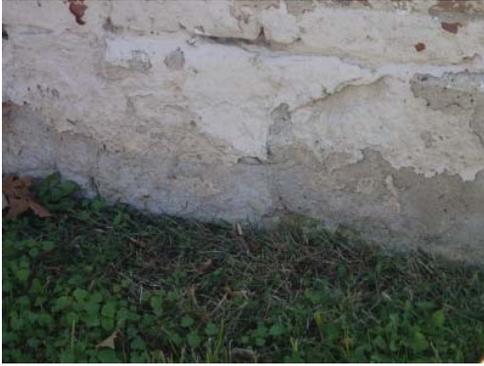
Photo PL 1 Deteriorated parge coat reception area (North)

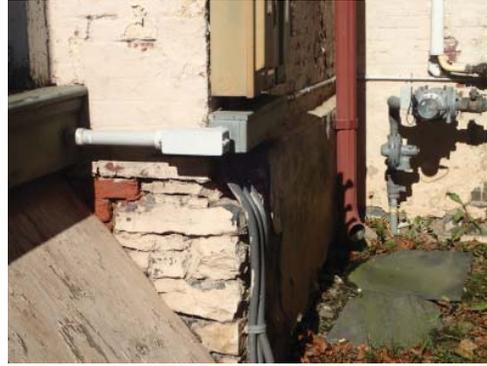
Photo PL-2 Deteriorated stone masonry mortar and parge coat

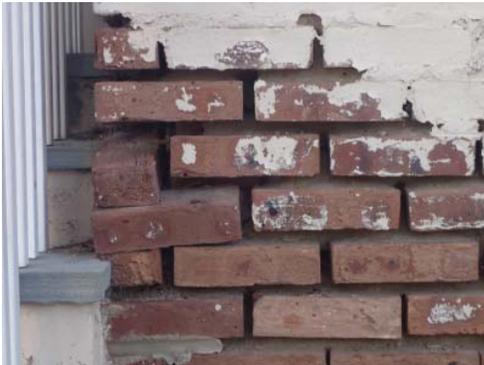
The exterior walls were observed to be of brick masonry construction. The basement walls are of stone masonry construction. The parge coat on the stone masonry has deteriorated. See photo PL 1 and PL 2 on page 155. Settlement cracks were observed throughout the exterior masonry envelope.

- 4) Compliance with various FEMA, NJDEP and NJUCC documents must be checked.
- 5) In conjunction with the historic building restoration consultant, the brick masonry must be repaired. We suggest that scaffolding be installed, and the wall be inspected in its entirety including all side walls, roofs eaves, coping, buttresses etc.

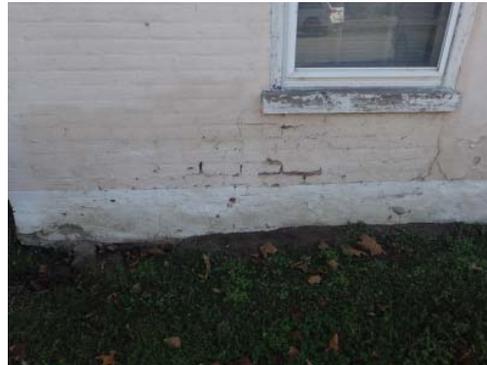
The brick is absorbing a lot of water. This is typical of older brick from the 1800's. The mortar joints are soft and appear to be constructed with lime mortar. There exists deterioration of the brick masonry from the contributory mechanisms of moisture saturation and leaching of the lime mortar. Leaching has resulted in the physical loss of strength and adhesion. Where leaching is severe, the mortar is weak and friable and is lost from the joints by either washing-out or by compressive extrusion in areas of high stress. This has resulted in local stress concentrations and loosening of masonry walls. See photographs PL 3 and PL 4 on the next page.

Photo PL 3 Washed out mortar in brick masonry

- c. All deteriorated (weak, crumbling, cracked or missing) brick and mortar joints shall be replaced and tuck pointed. Old mortar shall be removed to a depth of $\frac{3}{4}$ inch or deeper if it badly deteriorated. For all joints use a mason's chisel or a special raking tool. Clean out all joint surfaces with compressed air, brush, them wet with a stream of water and then replace with new mortar.

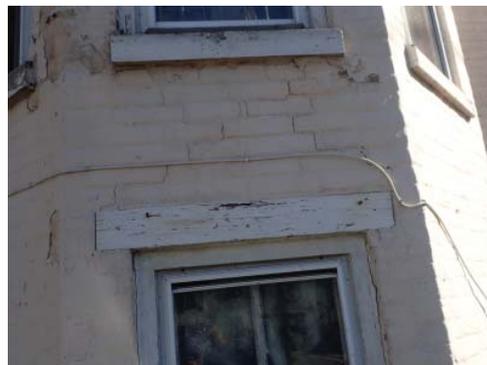
Some attempts at repointing and regrouting have been made in the past. Unfortunately, the mortar used appears to be a cement mortar and not a historic lime mortar. This repair is compounding the cracking and deterioration of the brick masonry. The use of cement mortar is developing stronger knife edge supports over which the brick masonry has to arch. The brick was never designed to function in this way. As explained earlier, this is causing stress concentrations within the mortar causing mortar to become weak and loose. See photo PL 5 on this page.

Photo PL5 Deterioration at locations of repointed mortar

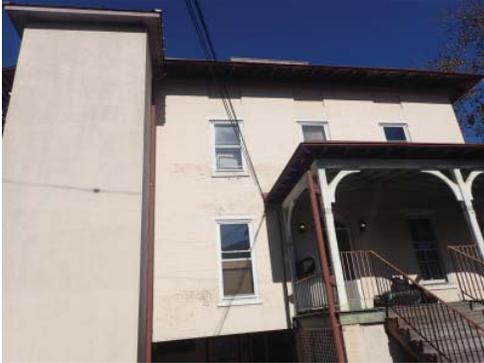
This has occurred both at the floor, columns and the roof eaves and soffit. There is a conspicuous lack of connections or nailing between various wood members. See photo PL 7 through 10 on this page. The exposed wood at roof eaves and soffits show signs of deterioration. See photo PL 11 to 12 on this page and photo PL 13 on the next page.

Photo PL7 South Porch on Lily St

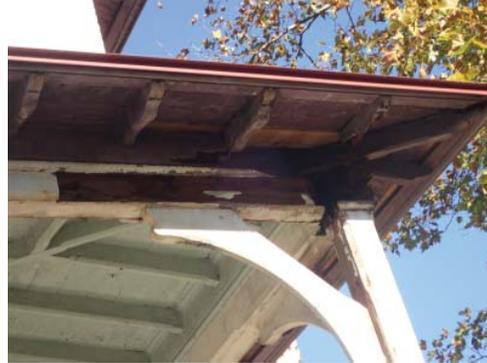
Photo PL8 deteriorated wood framing at eave of South Porch

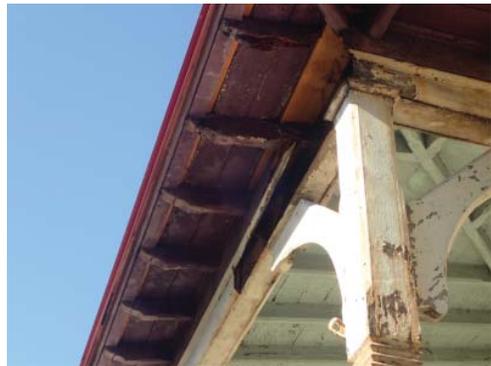
Photo PL 9 Deteriorated wood framing at eave of South Porch

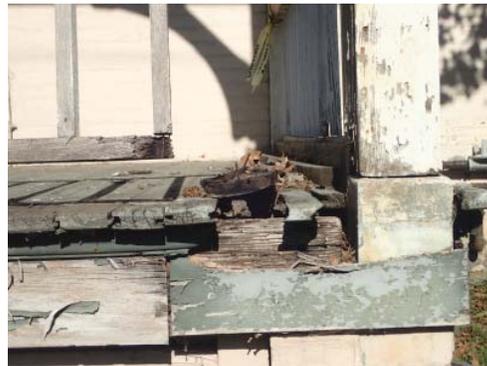
Photo PL10 Deteriorated wood framing at floor of South Porch

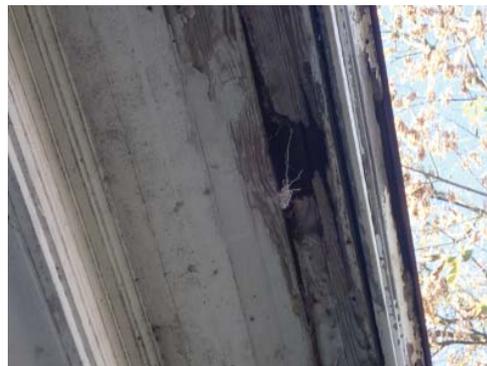
Photo PL 12 Deteriorated soffit at eave

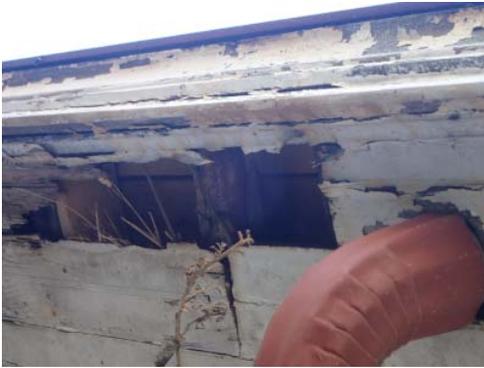
Photo PL 13 Deteriorated soffit at eave

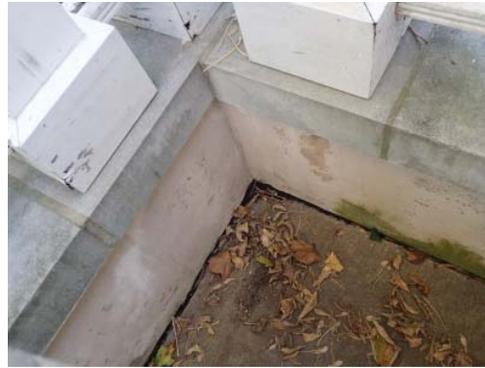
There exists settlement of the ramp slab on the east side of the library (towards NJ Highway 29). It is not clear by visual observation alone if this has been caused by improper compaction of the soil under the ramp slab or by washout during a flood event. As a result of this settlement the height of both the handrail and the guide rail is now non-compliant with the code. The settlement has also caused the handrails to come loose at the landing. See photos PL 14, 15 and 16 on the next page.

Photo PL 14 Settlement at handicapped ramp (East)

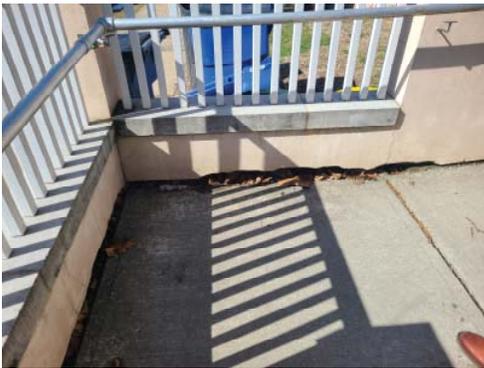
Photo PL 15 Settlement at handicapped ramp (East)

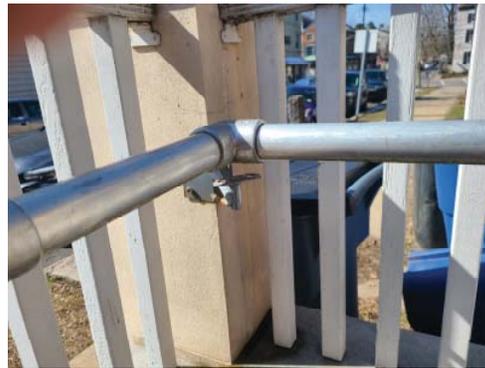
Photo PL 16 Loose handrail at handicapped ramp

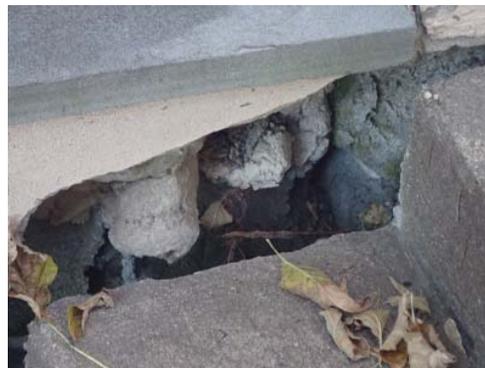
Photo PL 18 Closeup of settlement at stair

On the north side of the library building at the entrance stairs to the main reception area the stair slab has separated from the cheek wall to the North (towards the Exxon Gas Station). It could not be established by visual observation only if this is as a result of improper compaction of the soil or from flood damage. The condition is hazardous and could injure a person. See photo PL 17 and 18 on this page.

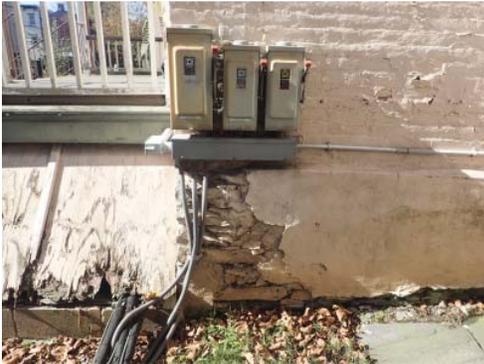
Photo PL19 Electric Utilities below flood elevation

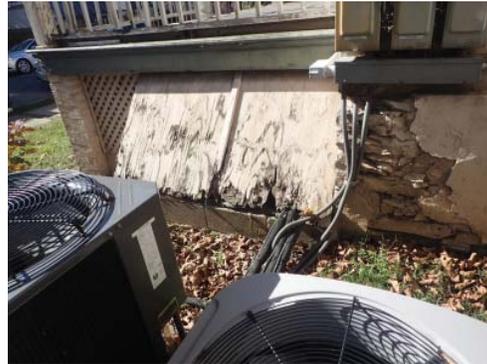
Photo PL 20 HVAC and wall opening below flood elevation

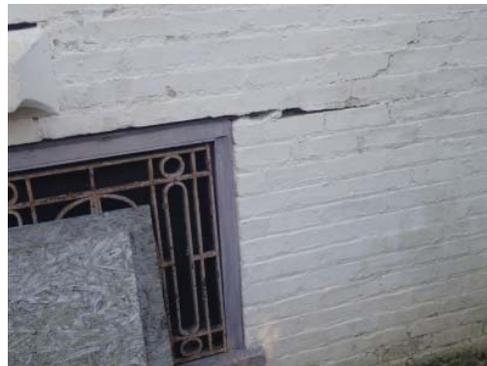
Photo PL 22 Wall opening below flood elevation

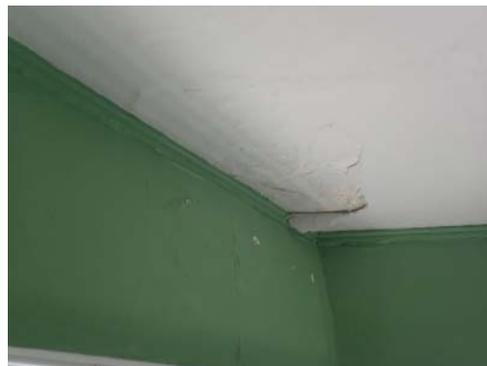
Photo PL24 Ceiling showing leaks.

Several ceilings show signs of water leaks. See photo PL 24 on this page and PL 25 on the next page. The finish and the sheathing has deteriorated. It is not immediately clear if these are coming from the roof or the wall envelope. It is also possible that at some locations it could be from the attic. The attic is being used for storage and for support of the mechanical units. It does not appear that any reinforcing of the attic floor joists and girders was attempted. See photo PL 26 and 27 on page 159.

- g. Follow all procedures in the masonry code and Brick Institute of America Technical Manual for hot and cold weather masonry construction.
- 8) Ceiling lath and plaster ceiling and walls to be patched where noted. See photo PL24 on page 158 and photo PL 25 on page 159.

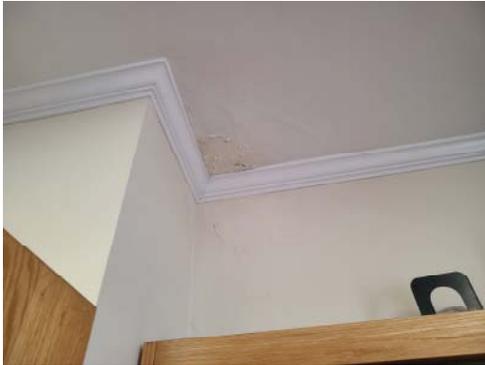
Photo PL 25 Water leak at ceiling

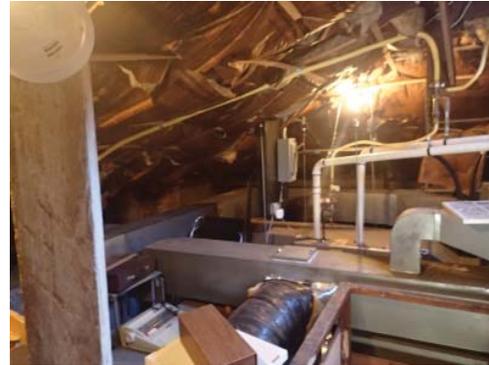
Photo PL 26 Mechanical units in attic.

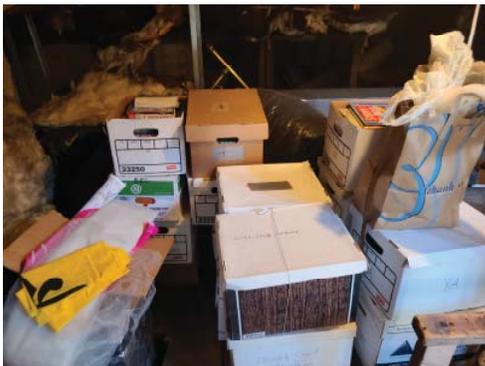
Photo PL 27 Attic being used for storage

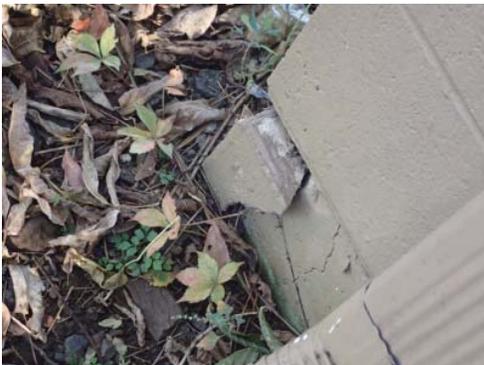
Photo PS 5 Damaged concrete masonry at southwest corner

The exterior walls are in fair to good condition. All the metal panels on all the faces need painting and caulking. The masonry walls require repointing / regrouting. There was loose masonry observed at southwest corner photo PS 5 on page 164. Please note that the numbers on the photographs on A101 reference that individual drawing only and not the report.

- 4) A scan of the roof for leaks.
- 5) Repair cmu at southwest corner photo PS 5 on page 164.
- 6) Repair perimeter column photo 8 on A101.
- 7) Remove and rebuild the cmu around the evidence room after installing a new footing or haunch in the slab to support the masonry.

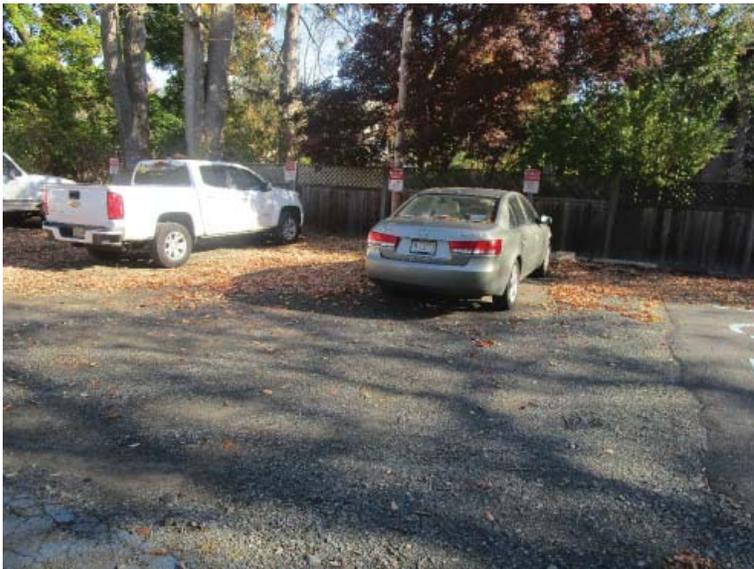
WOOD FENCE ALONG EDGE OF PARKING LOT

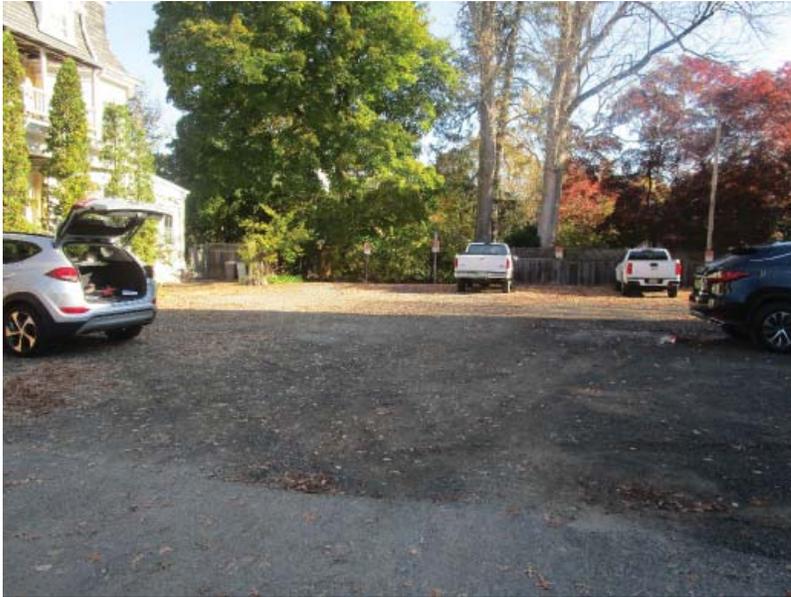
OVERALL GRAVEL PARKING LOT

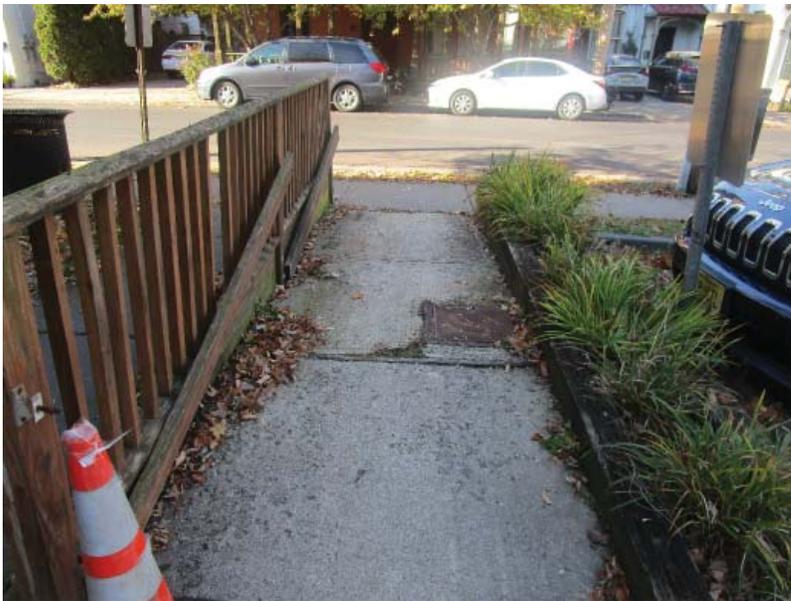
REAR SIDEWALK AND WOOD HANDRAIL
