CITY OF LAMBERTVILLE
HUNTERDON COUNTY

ARCHITECTURAL REPORT SUMMARY CITY OF LAMBERTVILLE

EXECUTIVE SUMMARY

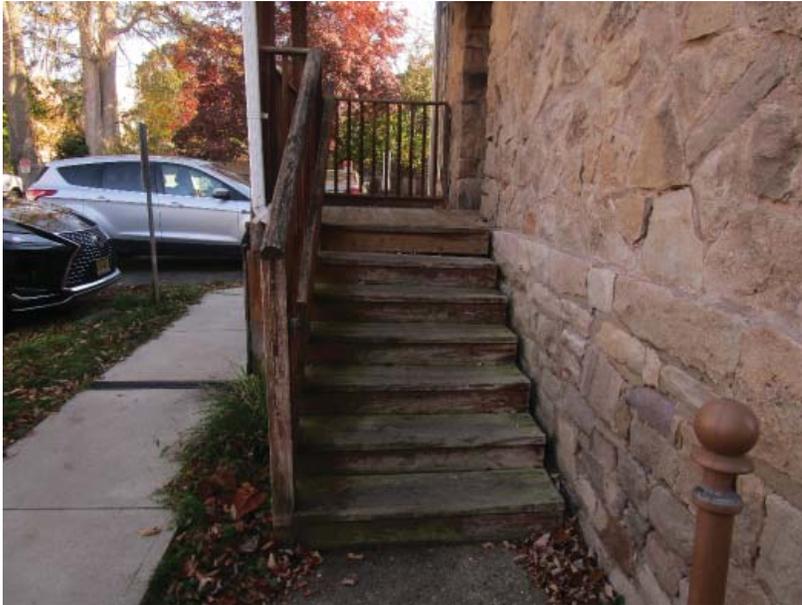
WOOD STEPS TO REAR ENTRANCE

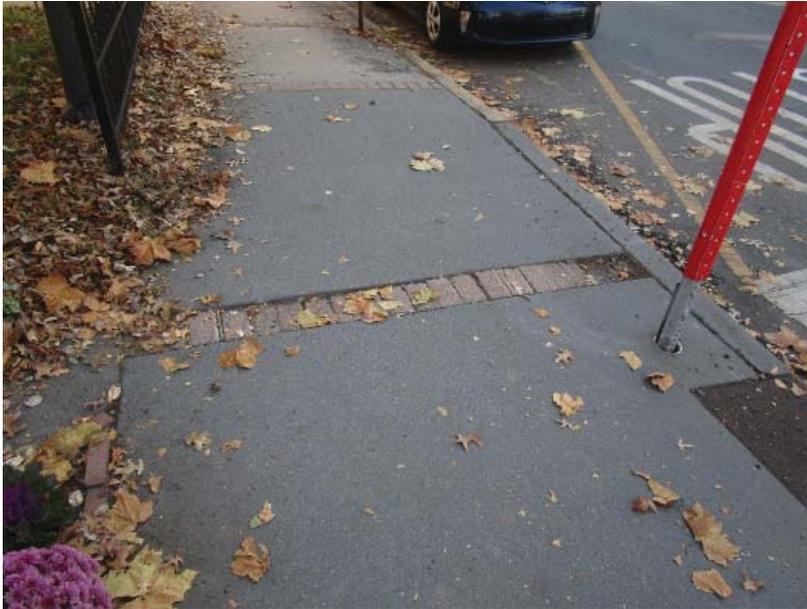
PAVER INSERTS IN SIDEWALK

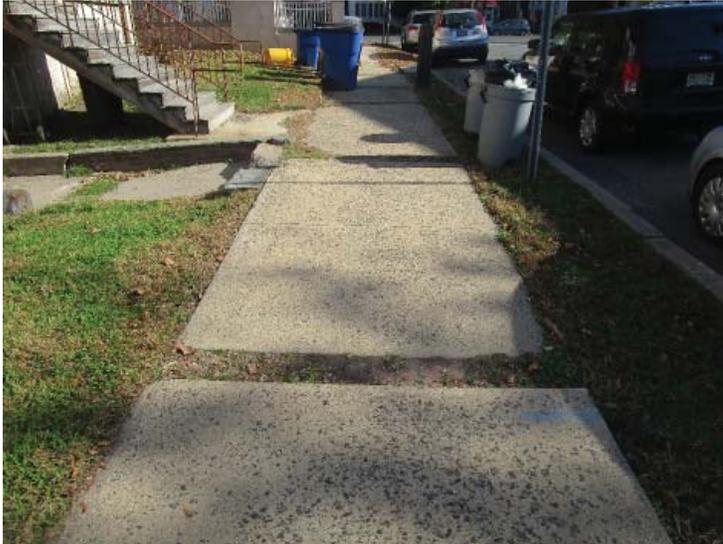
PAVER INSERTS & SIDEWALK NEAR LILLY STREET STEPS

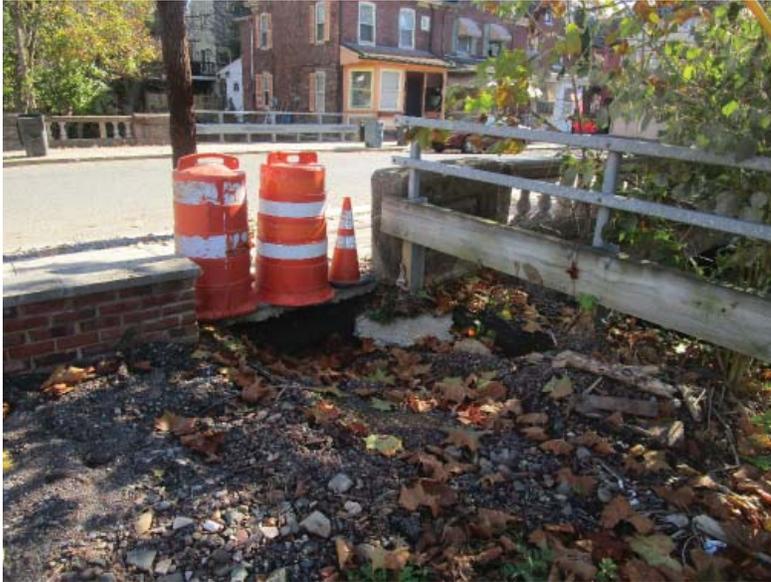
WASHOUT NEAR PARAPET WALL

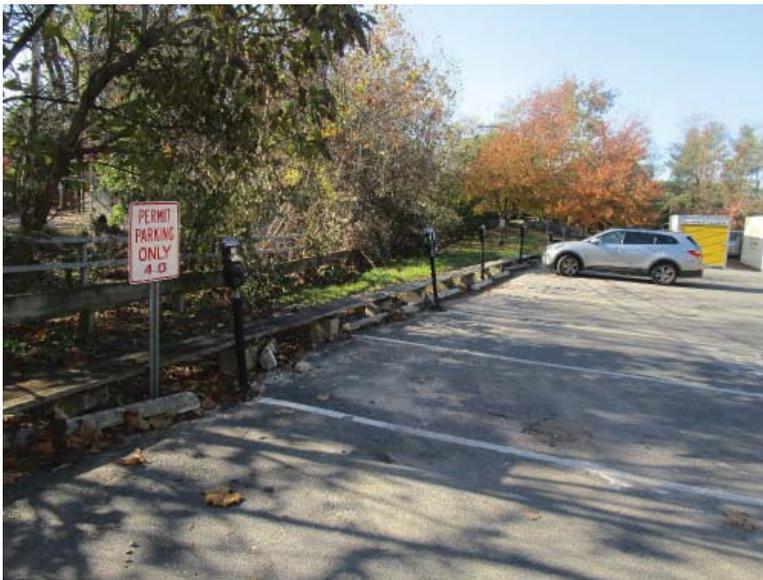
EDGE OF PARKING LOT WITH PARKING STOPS

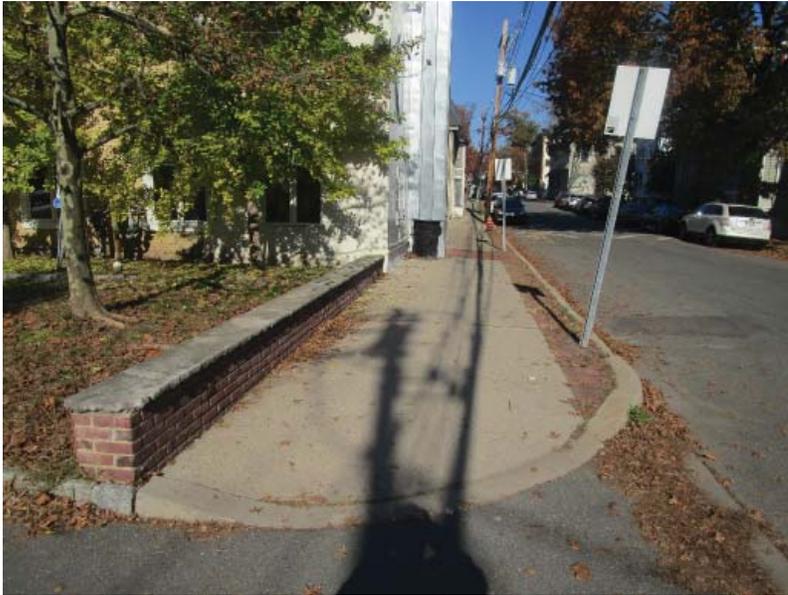
SIDEWALK ALONG SOUTH UNION STREET

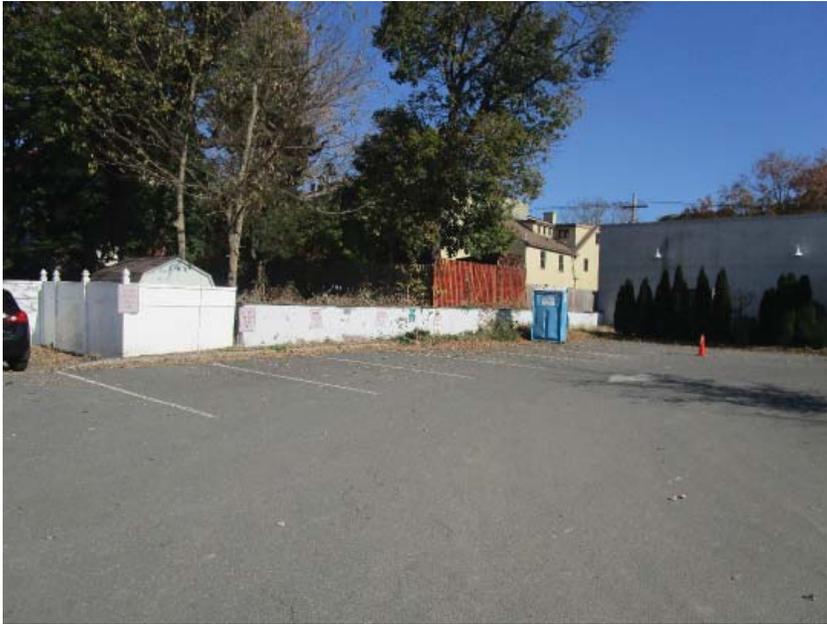
RETAINING WALL

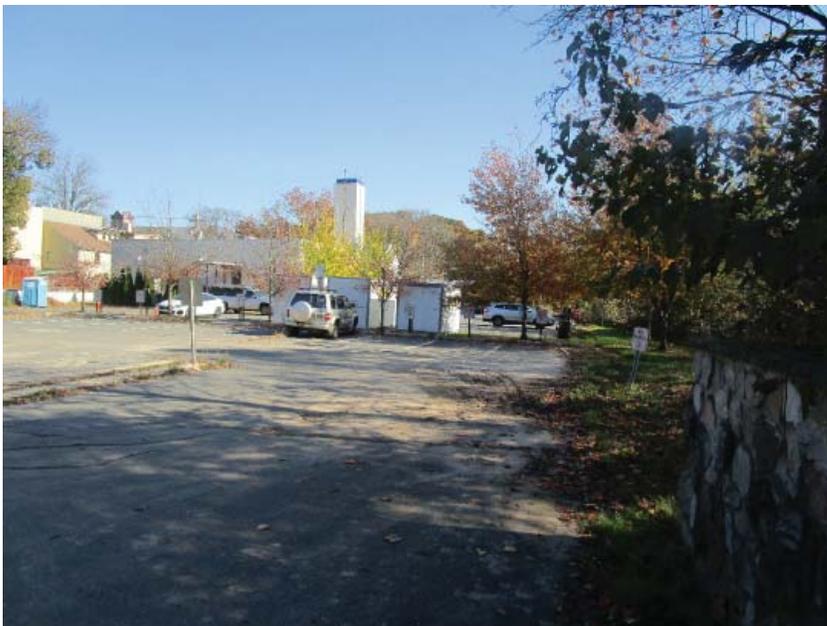
AREA OF APPARENT PONDING

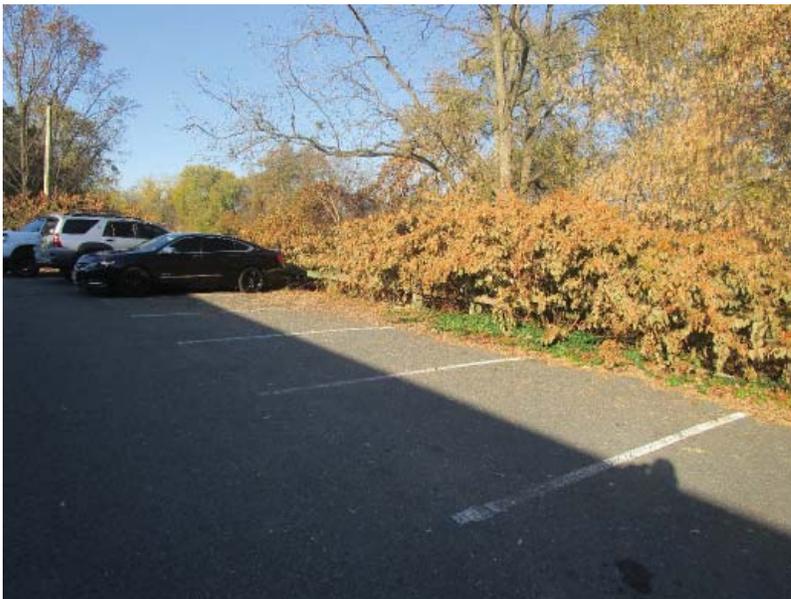
TIMBER GUARD RAIL

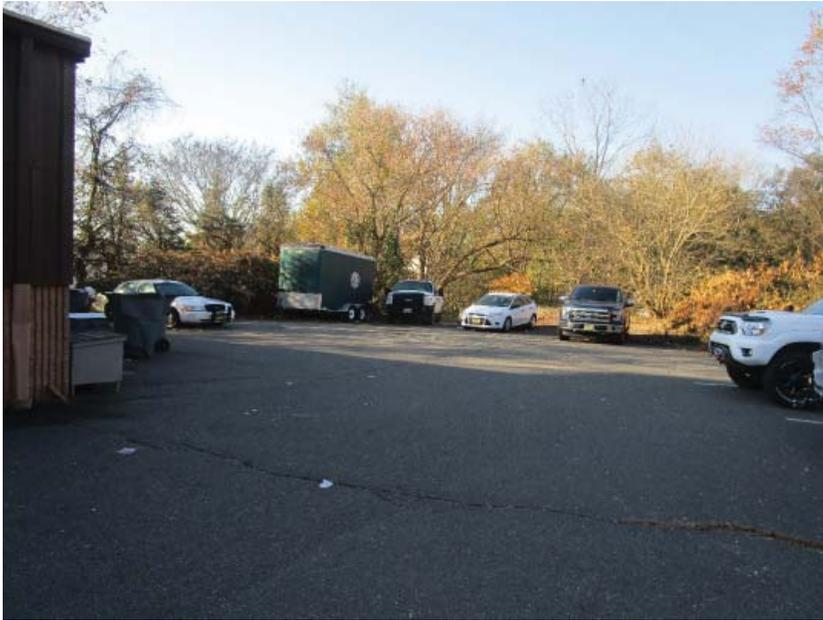
OVERALL PARKING LOT

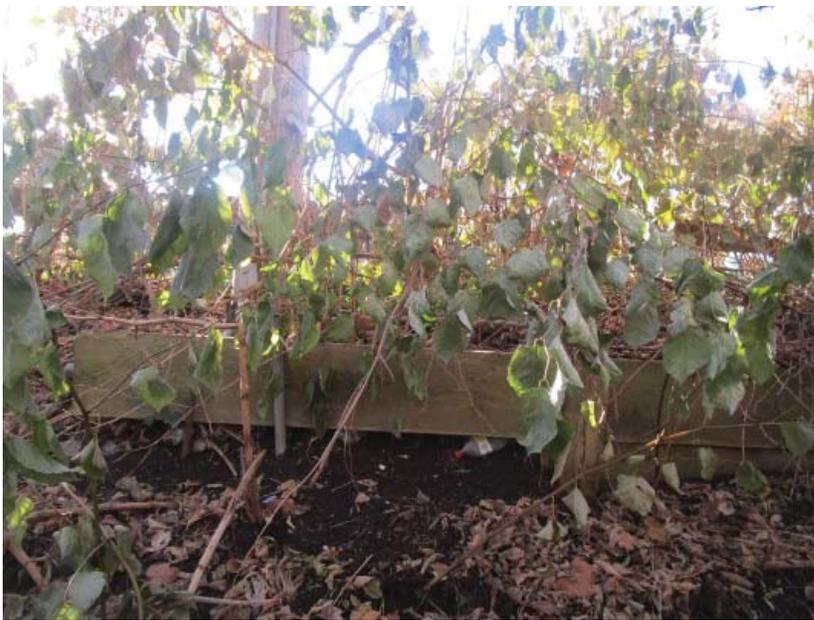
SLOPE EROSION
